Phase conductor break caused by snow accretion on 110 kV overhead power line

Zemljarić Borut, Zabukovec Peter, Jovanović Zeljko, Starasinić Martin
IBE, d.d., Hajdrihova 4, 1000 Ljubljana, Slovenia
E-mail: borut.zemljarić@siol.net

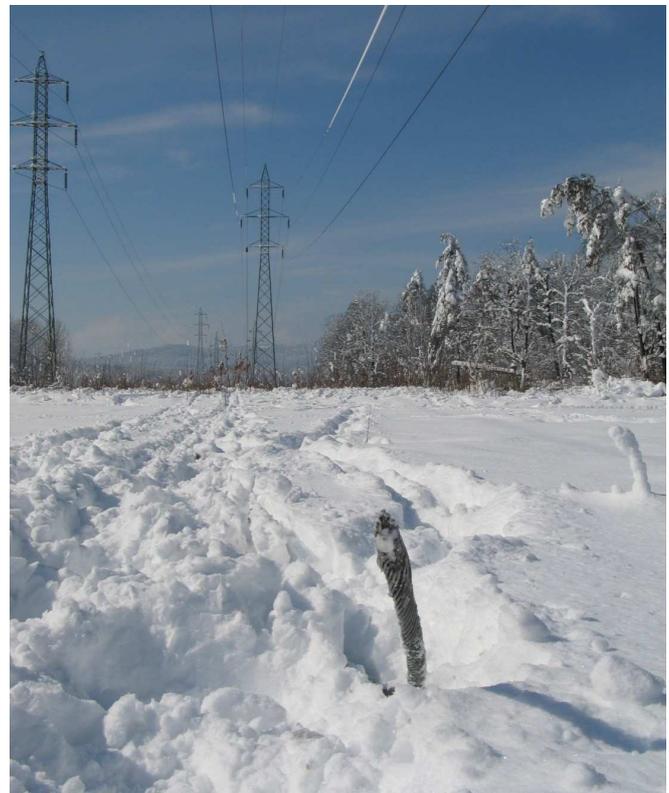
On March 5, 2006 at 19.44, after several repeated connections of the power line protection devices, the 110 kV Beričevo – Kleče OH transmission line faced a final outage from the electric power system. Following the intervention of the maintenance teams on duty it was established that due to extreme weather conditions which will be described in the continuation of this text the lower phase conductor broke in the line span between towers no. SM54 and SM55 and caused the line outage.

Fig. 1: Broken conductor on ground. (photo: M.Cernivec)

The additional load on the conductor caused its approaching the ground till final touching. With the power line automatic reenergizing the conductor started melting down and finally broke. Due to mechanical forces caused by the conductor break the conductor slipped out of the suspension clamp installed on the insulator set of the tower no. SM54 for about 6 meters. Further conductor sliding out of the suspension clamp was prevented by a bird cage installed by the clamp which is evident from the Figure 2. This resulted in highly increased sag between towers SM53 and SM54, and the conductor crossing the Sava River in this span not only touched the ground but even sank down under the river water surface. This changed also the sags between the other towers located in front of SM53 and after SM54.

Then they cut out the deformed part of the conductor and replaced it by a new one. The new conductor part which was added together with two compression midspan joints was 20 meters long. The reconstruction was accomplished by the conductor joining and its replacing into the suspension clamp of the insulator set.

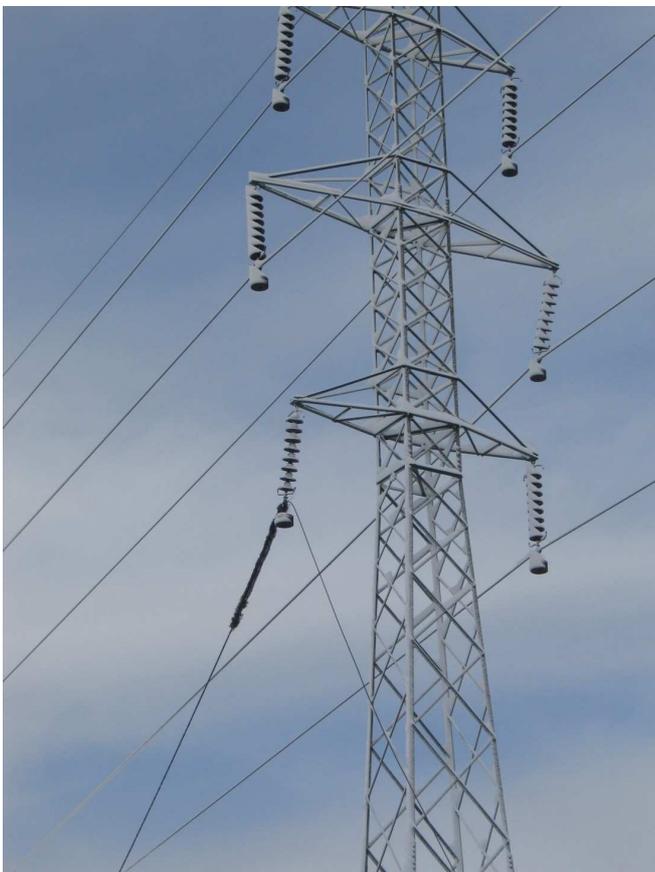
Fig. 2: Conductor sliding out of the suspension clamp. (photo M. Cernivec)

In this simulation the power line state at the conductor break between SM54 and SM55 and the conductor slipping out of the suspension clamp of the insulator set in the length of 6 m has been analyzed. A bird cage of the aluminum part of conductor prevented further sliding of the same from the clamp. In support of the broken conductor the straight line tower SM54 took over the role of a tension tower. The conductor length extended for around 8 m. The difference of sags due to the conductor length extension in the section is given here below. The most critical sag occurred in the span crossing the Sava River. The conditions are given in Figure 7.

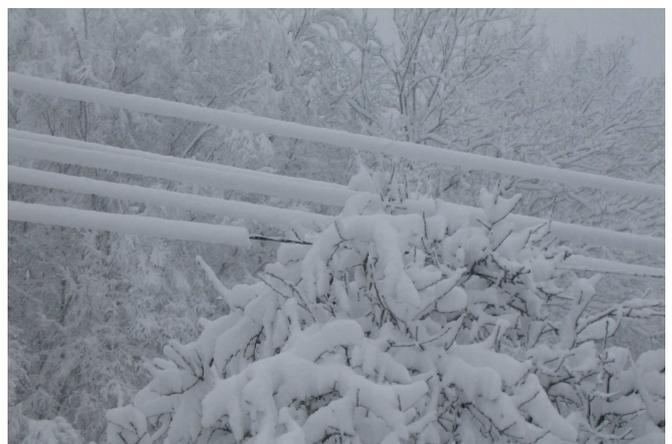
Fig. 4: Low voltage network under snow cover on 5. March 2006. (photo B.Zemljarić)

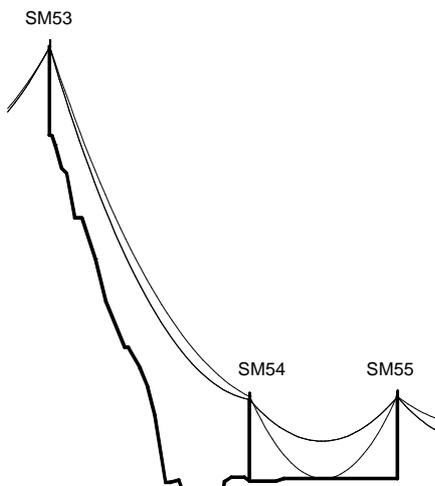
Fig. 5: Longitudinal profile between SM53 and SM55.

The chapter gives a reconstruction of the additional snow load size which resulted in the power line conductor touching the ground. The snow load foreseen by the simulation was supposed to be only on the damaged span between towers SM54 and SM55. The section of the longitudinal profile encompassing the point of the conductor touching the ground is given in Figure 5.

The upper catenary gives the position of the upper conductor in normal operating conditions while the lower catenary gives the position of the conductor at its touching the ground. The conductor safety height above the ground was around 8 m. Since no data regarding additional load on the conductors during the event were available, two options were simulated:

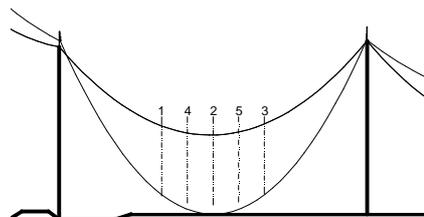
Fig. 6: Additional load points in second study case.

In the second simulation made in the same weather conditions the span between SM54 and SM55 was divided into three thirds. The load was simulated only on 1/3 of the central sub-span. The continuous one-third load was simulated by five points in the central sub-span, see Figure 6. By iterative addition of constantly applied same parts of load in the previously mentioned points it has been established that at the moment when the conductor reaches the ground this load achieves 77.5 daN. The calculation result is given in Table II.

The results show that an additional load smaller for 10 kg and applied in the previously mentioned points of the conductor decreases the sag for around 63 cm. The table also gives that in case of a simulation of an unequal load in the span the conductor reaches the ground at a minimally increased load.

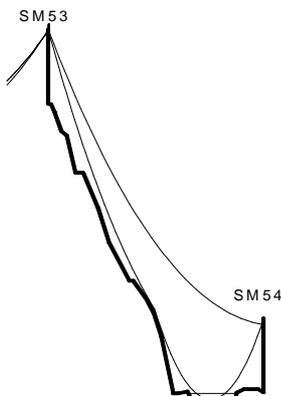
Fig. 7: State of the sag after conductor breaking.

The upper conductor represents a normal state while the lower one gives the state after the conductor breaking when it plunged down into the Sava River with highly increased water

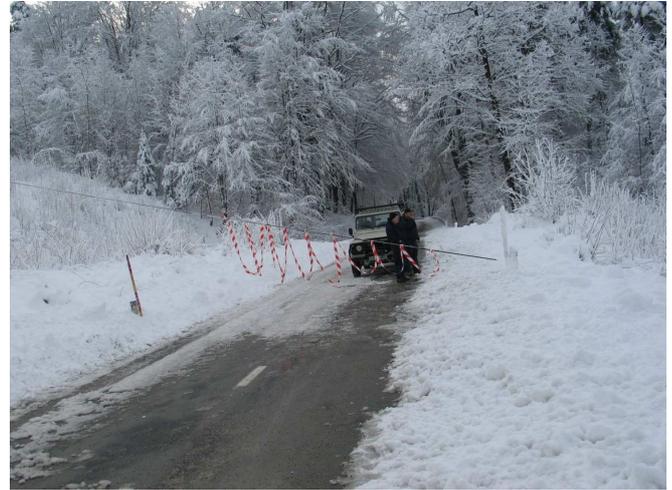
level. In this span the power line crosses also a local road which had to be closed temporarily due to the increased sag. The conditions, where conductor reach the road and marking them with red ribbon are shown in Figure 8.

Fig. 8: Damaged conductor on the road. (photo M. Cernivec)
