Analysis and Prevention Measures of Trapping of 1000kV ChangNan I Line

Li Junfeng¹, Shi Shengzhi¹, Dong Bingbing² and Jiang Xingliang²

Keywords-1000KV ChangNan I line ; insulator icing flashover reason analysis ; preventive measure ;

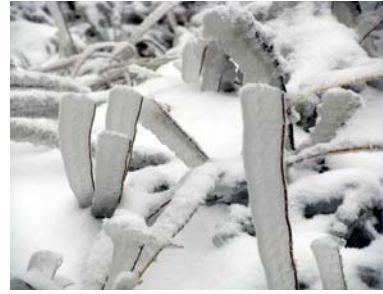
Figure 3. Icing condition of ground along the 666~667th line

The fault took place at February 16. The patrol officers found the body of the No.666 and 667 tower have a slight icing with the thickness of 5 mm, during the special patrol on February 14.

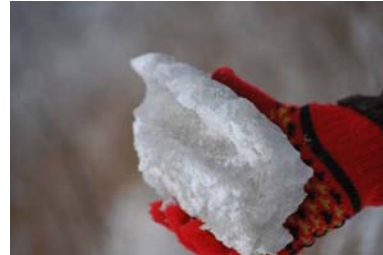
Figure 4. Ice shedding sample of 667th

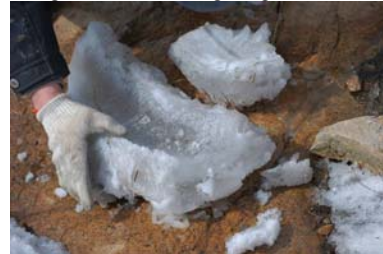
Figure 5. Icing shedding sample on grading ring of 667th

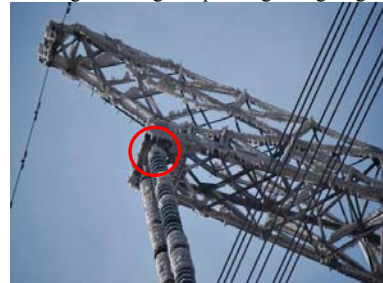
After careful checking on the tower, the trace of flashover were found on the cap and the shed of the first insulator of small side of the A phase, grading ring of high voltage side and transmission line of small side on the 667th tower. It was identified initially as the fault point caused the trapping of the line, and it does not affect the operation of the transmission line.

The figure 6 shows the A phase where flashover took place. The burn location of the insulator and its situation were found in the red circle. The figure 7 shows the C phase where flashover took place. The figure 9 and 10 show the flashover point of the high voltage side.

Figure 6. Icing condition of insulator and cross arm of A phase after flashover(front side is small side)

It was a longer period (February 7 ~ February 14) of continuous rain snow weather before icing flashover occurred. The air humidity is high, and there is some weak ice on the insulator surface. But the sheds of the insulators can not be connected. In the time slot of February 14 to 16, there is snow accompanied northwest wind (4~5). The of

trapping is 12:41 pm. This time is the noon, so the temperature has been picked up, and the surface of ice on the insulator begun to slowly melting. The water of the melting snow formed water film, and a short channel was formed on the insulator. As the temperature increased further, the water film on insulator surface is thickening, and the degree of moisture increased gradually, leading to a rapid increase of leakage current on the snow surface. The partial arc firstly formed at the cap the first insulator (low side) connected to steel and the place between the grading ring and the insulator tip of the lower part of icicle. During this period, insulator strings may also have other partial arc, followed by partial local electrical arc that causes ice to melt off. The leakage current intensity was increased by the melted snow. The arc is stretched or extended upward, eventually leading to arc connectivity, resulting in tripping accidents. At the flashover instant, a large area of ice was shedding from the insulator surface caused by the high-temperature of the arc. The shed of the porcelain insulator was dried, and the flashover channel was eliminated naturally. The insulated performance of the insulator string restore to a greater degree, so a successful line reclosing is carried out.

1) The video surveillance system can be established at tower No.667. The current 3G communication technology may be used to monitor circuit operation real-time. While a professional monitoring station could be set up at the same topographical and meteorological characteristic. The operational department can take remedial measures to avoid damage to line trapping cause by icing or adverse weather. On the other hand, it can provide convenience for collecting and accumulating long-term meteorological changes, videos, images and data information for transmission lines, which provide the basis for the design and operation and maintenance. And it is easy to carry out related technology.

2) The insulators with large diameter could be used. It can block the path icicle bridge by change the insulator in to insulator with large diameter at the top, middle and bottom of porcelain insulator string suspended in a straight line. The type '3+1' can be used in 500kV transmission line. That is to say, the big diameter insulator is used between three common insulators. The operational result is good, from the situation in recent years.

3) Consider to use the method of inclined suspension insulator. We can adopt the 'V' type and '^' type or increase deflection angle along the direction of the insulator string line. It can block the icicle bridge between adjacent insulator chip connectivity, to a certain extent. Through that the icing flashover voltage can be increased.

4) Application of technology by climbing skirt. On the insulator string, large diameter silicon rubber umbrella group are installed in every 5 to 6 insulators, the umbrella group can increase the diameter of insulator, prevent the surface of insulator string was covered completely. The measure was experimental used on the icing tower for the first time in 2010 April. It has not affected the normal operation of lines, and the anti-icing effects can't be tested now.

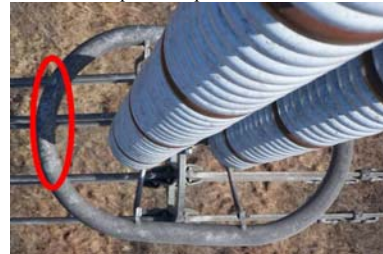
Figure 9. Picture of flashover spot of grading ring of 667th

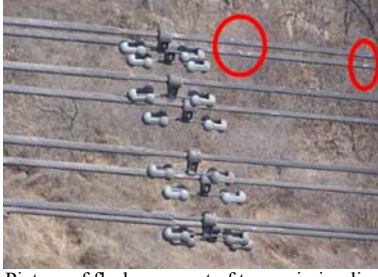
Figure 11. Picture of flashover spot of transmission line of 667th

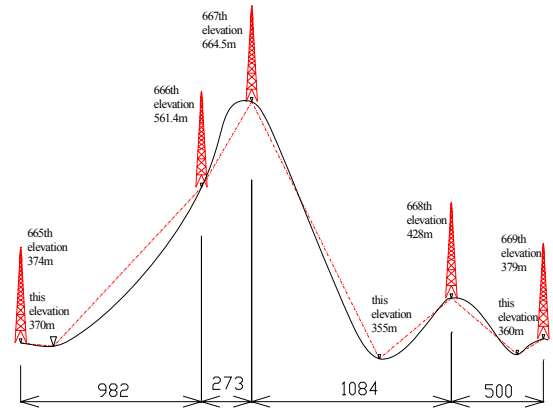
The figure 11 shows the profile chart before and after the 667th tower. From these figure, it easy to know that there is an approximate narrow and broad plain, about 5 km wide South-north, along the East-West direction at the middle of this section. The 667th tower located at the highest altitude of this section. The elevation rise rapidly and then decline. It is the type of microclimate area in the

rapid uplift of the micro-topography terrain. The direction of cold air from the North gradually changed from the level of oblique when meet the upward elevation of 665 ~ 667 of the mountain, and the wind speed gradually increased. At the same time, the humid air lift valley to the mountain top and wind speed, humidity Peak, and then gradually slow down over 667, shown in Figure 12. Changes in meteorological parameters increased the formation of ice on insulator, leading to transmission line icing load increases. The patrol officers have a personal experience during they patrol from the foot of the mountain road to the place at tower 667th. With the increase of the altitude patrol officers climbing, the wind speed v increase gradually from small to big, the temperature increase gradually from high to low. On the peak, humidity w is relatively large. According to the equation (2), the larger of the wind speed the more ice. So, the icing is gradually serious with the rise of terrain of the 665th~667th tower.

Figure 13. Profile chart before and after the 667#

5) The design department should search detailed information, survey of icing, lightning, and other micro-meteorological zone, when the transmission line is designed. The design line should avoid the micro topography, microclimate areas as far as possible. If it can't avoid and need to cross which subject to condition, some necessary measures should be taken. Or section design is need according to the actual situation. The tower in the serious icing area should be designed as enhanced line tower, base on seriously studying the long-term reliable observations of ice and considering a revised data.
