ANALYSIS AND SIMULATED RESEARCH OF TOWER COLLAPSE BY ICE DISASTER OF HUNAN IN 2008

Lu Jiazheng, Xu Xunjian *, Liu Chun, Fang Zhen, Li Bo, Zhang Hongxian
Power Transmission and Distribution Equipment Anti-icing & Reducing-disaster Technology key
Laboratory of State Grid, Hunan Electric Power Test and Research Institute, Changsha, China, 410007

Abstract: The damage of the transmission lines in Hunan during the 2008 ice storm is surveyed and the main causes of the tower collapses and line failures are analyzed. It is found that the situation may be worsened by the nonhomogeneity of the ice accretion due to microtopography and micrometeorology conditions, span distance, and the imbalanced tension caused by vertical load. Meanwhile, simulation models of power transmission line and tower using finite element method have been proposed and developed. It is pointed out that great differences of span and angle of height are the main factors which cause unbalanced tension and make tower falling down. The computation results of 500 kV Fusha line I show the finite element method is very effective.

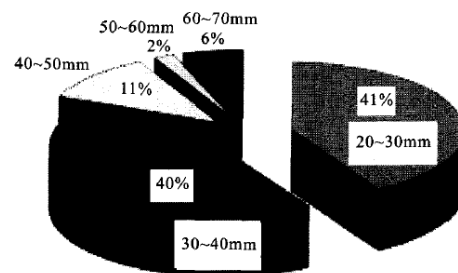
There were 182 collapsed towers in 500kv transmission lines, 176 towers among collapsed towers are designed by 15mm ice accretion thickness. 6 towers designed by 20mm is

centered in Jiangcheng DC line. Towers designed by 30mm were not collapsed. The ice accretion thickness of collapsed towers is shown in Figure 1.

Fig.1 Distribution of ice thickness on the failed lines

There were 427 collapsed towers in twelve 220kv transmission lines, only one tower is designed by 20mm ice accretion thickness, the rest are all 15mm. The ice accretion thickness on the collapsed towers mostly fall in the range of 20~ 40mm.

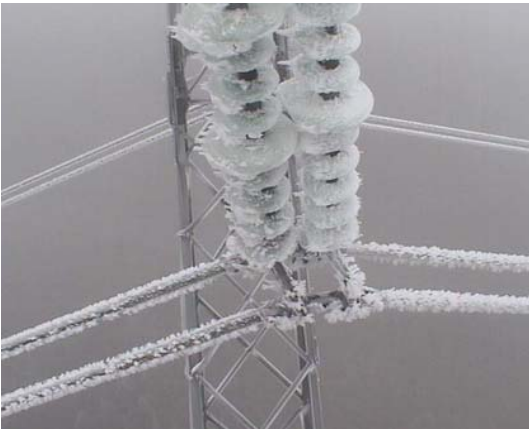
Because of the distance between the two sides of the conducting wire is different, in the case of ice covering the pressure between the two sides of the conducting wire is also dissimilar.^[2] It is the difference that may fall the tower pole down. This type of falling is common for example the falling cases between #979 tower and #983 tower in Jiangcheng line, in which the insulation object is totally covered by the ice accretion and the thickness of the conducting wires is more than 30mm and the tower pole whose average is more than 40 is up to 100mm. The distance between the preceding and the following tower pole of #983 is up to 722m, which make the unbalanced pressure which cause the falling case. #983 tower fell down forward to large side (span distance is greater), drawing the adjoining tower poles of #982、#981、#980、#979 down(Figure 2).

Figure 2 Ice thickness on the Jiangcheng-line failure

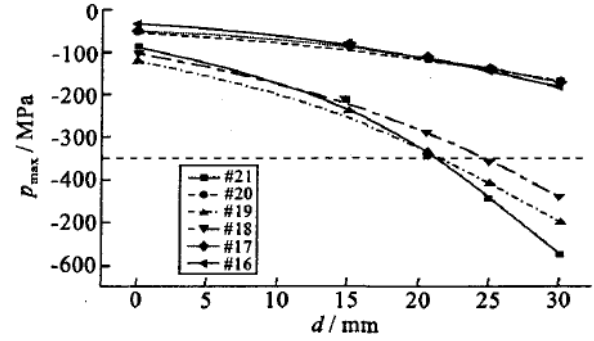
The maximum compressive stress of towers is p_{max} by calculation. Variation of p_{max} with d is shown in Figure 4, dashed line correspond to yield limit of towers. As shown in Figure 4, when $d=20.6mm$, the p_{max} of tower achieves yield stress. With the d going up, p_{max} of # 19 tower achieves yield stress. When d is close to 25mm, p_{max} of # 18tower achieves yield stress. When $d=30mm$,the strength of #16, #17 and #20 meet the demand.[7]

Figure 4 Transmission tower's maximum compressive stress varied with the ice thickness

As shown in List 1 , when $d=20.6mm$, unbalanced tension of # 21 tower is 56.36kN, compressive stress acting on main materials at the bottom of crank web is 345Mpa , , it collapsed # 21 tower closed to large side, then, # 20、 # 19、 # 18、 and # 17 towers were pulled down in turn. Because 33.359KN opposite-direction unbalanced tension acts on # 16tower, most tension by dilapidated # 17tower is offset, the unbalanced tension resistance is strong. # 16tower merely produces local deformation.

In order to deal with the frozen weather disaster, some emergency programs should be improved, the designed level of ice covering should be 20mm at easily affected area, the smallest skeleton frame should be constructed, the researching and applying work for ice melting and monitoring should be quicken, the electricity supplying volume at main circuit should be raised in case of conducting wires frozen, and the monitoring work of microtopography and micrometeorology and drawing work of ice area distribution should also be done.
