Climate Conditions of Frost-Phenomena Adherent to the Overhead Lines

Dr. Y. Kamata^{*1}, Mr. M. Shishido^{*1}, Dr. T. Fujii^{*1} and Prof. K. Okada^{*2}

1. Railway Technical Research Institute, 2. Kokushikan University
2-8-38 Hikari-cho Kokubunji-shi, Tokyo, 185-8540 Japan, kamata@rtri.or.jp

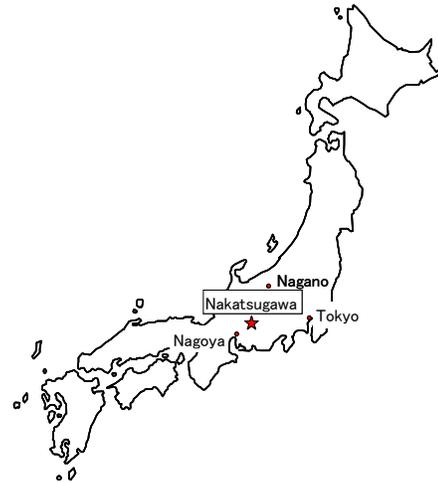
Observation site of the overhead line frosting was chosen at Nakatsugawa-shi (Gifu prefecture) nearby the station (figure 1) because it is easy to post the facilities such as weather surveying instruments. This site is located in the mountains, and a temperature fall by the radiational cooling is easy to occur during the winter season. In addition, there is Nakatsugawa River near the site, that is the branch of Kisogawa River, and then the humidity is easy to rise. In this way, the condition of outbreak the frosting is prepared.

Fig. 1. Observation site

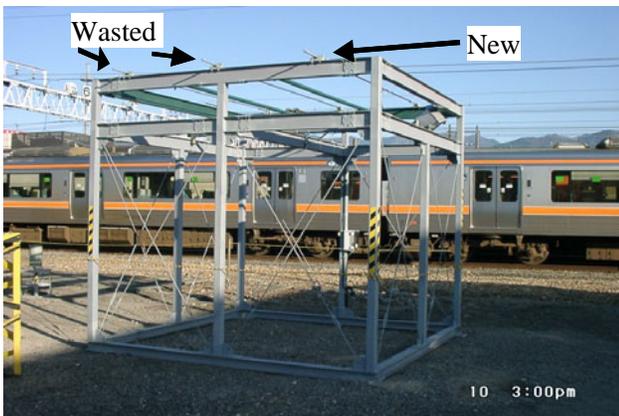
Fig. 3. Establishment situation of mock overhead lines
