Icemeater tests at Studnice Station

Ing. Jaroslav Šabata, Ing. Lubomír Zeman
EGÚ Brno, a.s.

Abstract— The test site Studnice, which is described in another paper at this workshop, is among 5 other station through Europe that has been used for testing icemeters and validation of icing models.

Two instruments – Combitech IceMonitor and Goodrich Rosemount ice detector were tested in the winter 2007/08 and 2008/09.

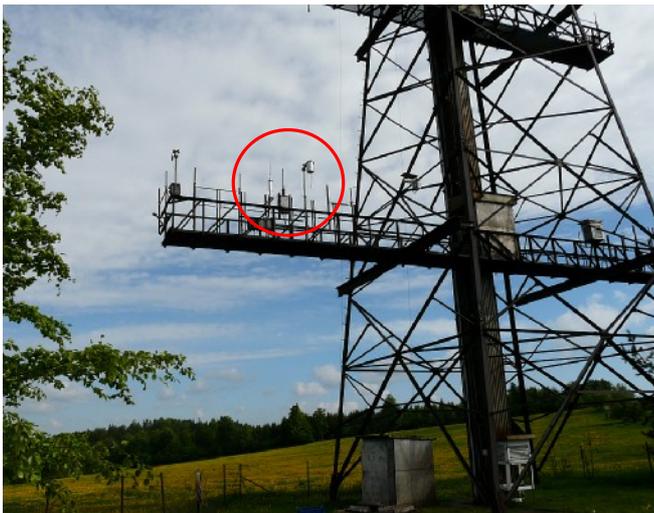
Combitech IceMonitor and Goodrich ice detector were installed at the platform 10 m above ground (see Fig. 1).

Fig. 1 Platform at 10 m with instruments

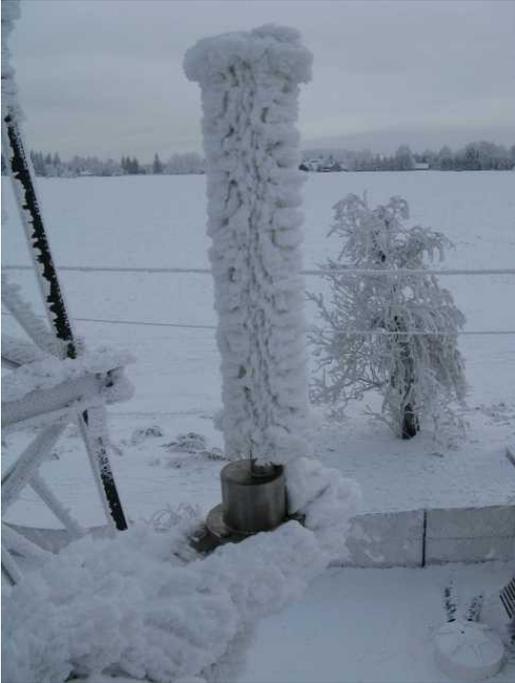
Fig. 3 Combitech IceMonitor

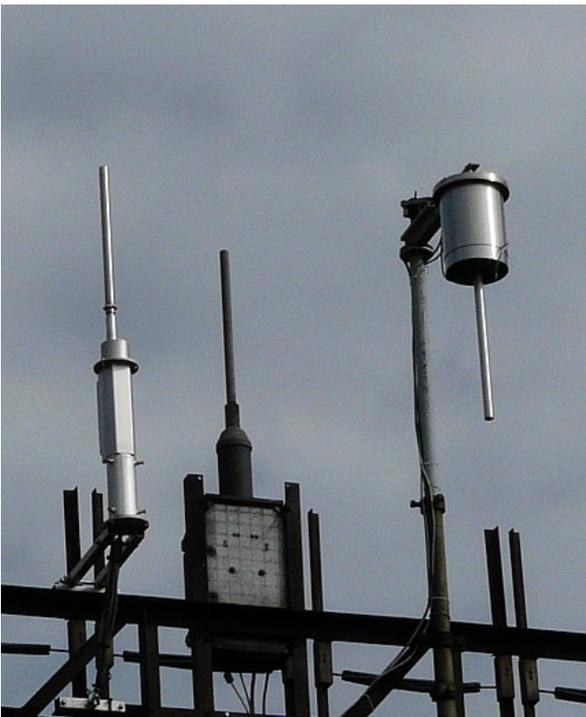
Combitech IceMonitor was put in operation on 3rd October 2008. Updated version was installed at Studnice February 20, 2009 (see Fig. 4).

Fig. 4 Updated Combitech IceMonitor (left) and METEO (right)

Some improvements have been made (electronics, main body, fixing of measuring rod etc.) on the updated IceMonitor.

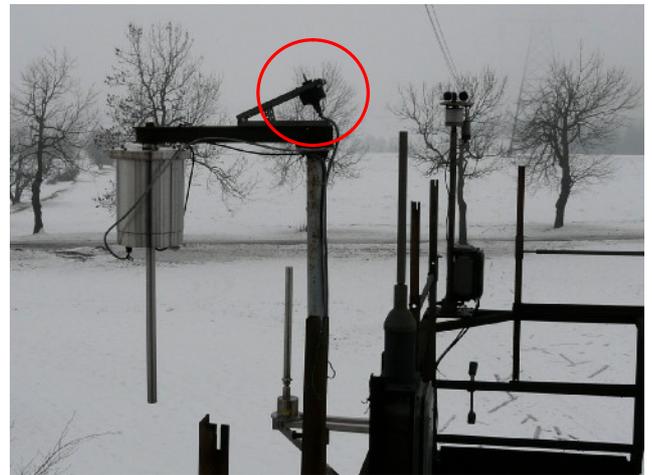
Fig. 5 Ice detector Goodrich and METEO on the platform at 10 m

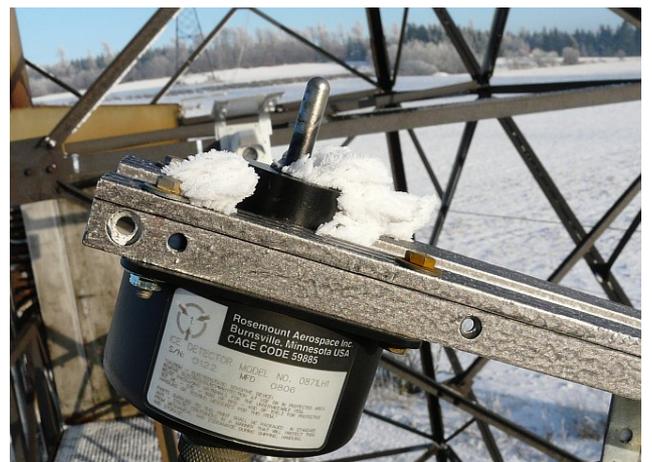
The second instrument selected by the Action was Goodrich/Rosemount (USA) ice detector. The tested instrument was model 0871LH1. The model is a low power sensor designed specifically for light ground-based freezing rain conditions. To detect the presence of an icing condition, the ice detection probe vibrates ultrasonically at a nominal resonant frequency of 40 kHz. As ice accretes on the probe, the added mass causes the resonant frequency to decrease, which initiates a self-deicing cycle that removes all accumulated ice from the probe.

Fig. 6 Ice detector Goodrich in detail

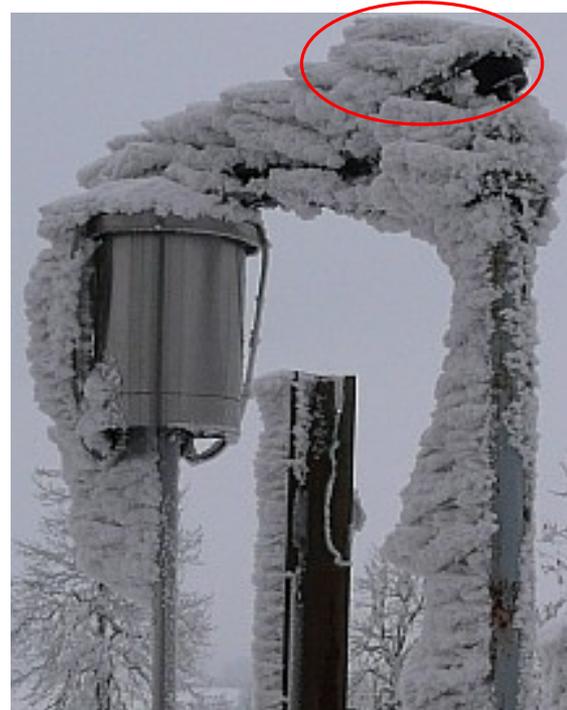
As can be seen from next picture (Fig. 7) when heavy icing occurs the heating power is not able to melt the ice round the sensor. In this case the sensor might give false signal on ice formation even though icing formation has stopped. But as stated before, this sensor is designed specifically for light

freezing rain conditions, not for (heavy) in-cloud icing, which was this case.

Fig. 7 Ice detector Goodrich fully covered with ice
