# Two years of icing monitoring at Nygårdsfjell Wind Park

*Abstract*— Icing at Nygårdsfjell Wind Park was monitored for two winters (2007-08 and 2008-09) and production data during the same period was studied to determine production losses due to icing. The wind park consists of three 2.3 MW pitch controlled Siemens wind turbines, in northern Norway. The wind park is in mountainous terrain above tree line. Instrumentation consisted of standard wind turbine instrumentation, an optics based icing sensor on the nacelle, and two web cameras monitoring the blades and the other instruments. An evaluation of the icing sensor performance relative to the wind turbine production losses was performed. Experiences with the web cameras are also reported.

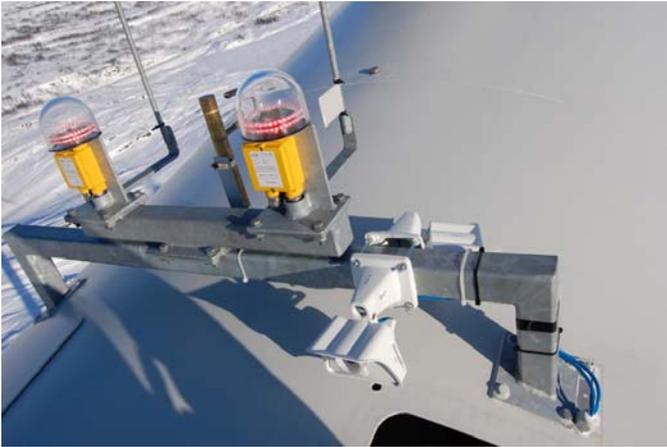
Figure 1: Web cameras installed on light boom.

Heat lamps were mounted on short booms to keep the cameras clear of ice during the winter. The operation of the heat lamps was simply that they were on all of the time. New bulbs were installed near the start of the icing season to ensure best possible operation during the winter. Figures 1 and 2 show the cameras installed on the wind turbines warning light boom. The camera was able to capture some images with icing clearly visible on the blades, and an example can be seen in figure 3.

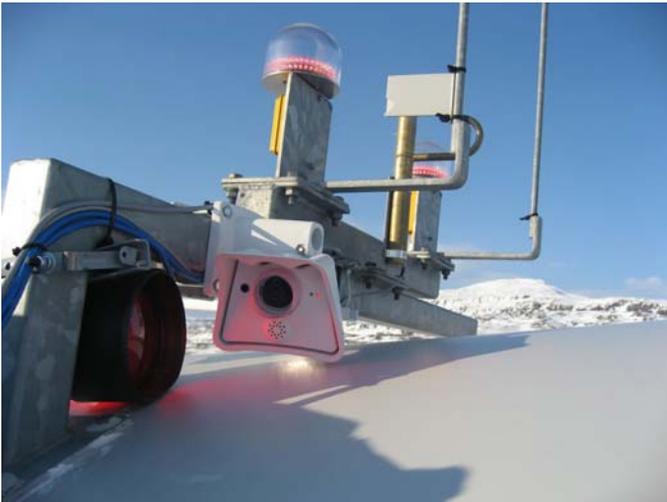
Figure 2: Web camera mounted on light boom.

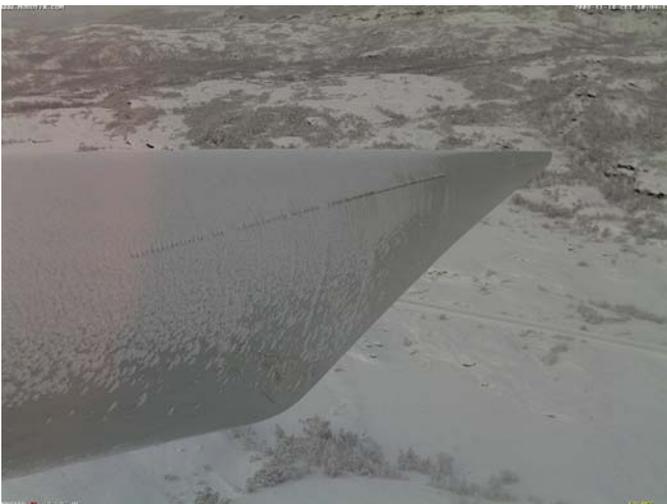
Figure 3: Icing documented by web camera.

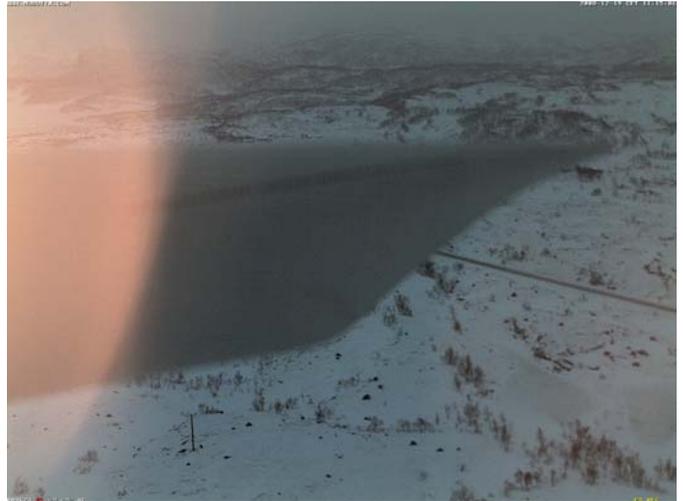
Figure 4: Icing indicated by HoloOptics, but there is too little light for the web camera to capture a clear image.

Having adequate light for good quality pictures was a challenge, especially during the winter when the light period of each day is quite short and on the cloudy days when icing is of interest. Figure 4 illustrates the type of images from these kinds of periods. The camera automatically lengthens the image exposure time when there is less light, but this necessarily causes blurring of the moving blade. The motion detection seemed to be less reliable during darker periods, but as the image quality during such times was typically low that does not seem to be a major issue.

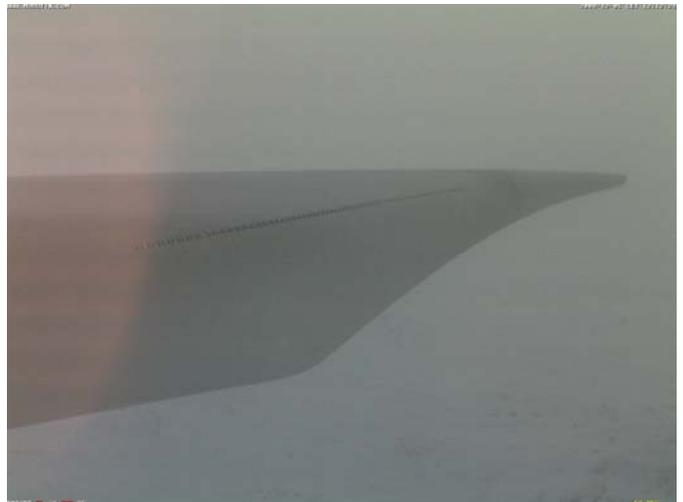
Figure 5: Icing indicated by HoloOptics, but fog and low light makes it impossible to detect icing visually.

Fog or low clouds also disturb visibility in addition to absorbing light. And, as figure 5 shows, the image quality during foggy periods also suffers. Figure 5 was taken during a time period when the HoloOptics sensor was indicating ice accretion but this can not be confirmed from the image of the blade.

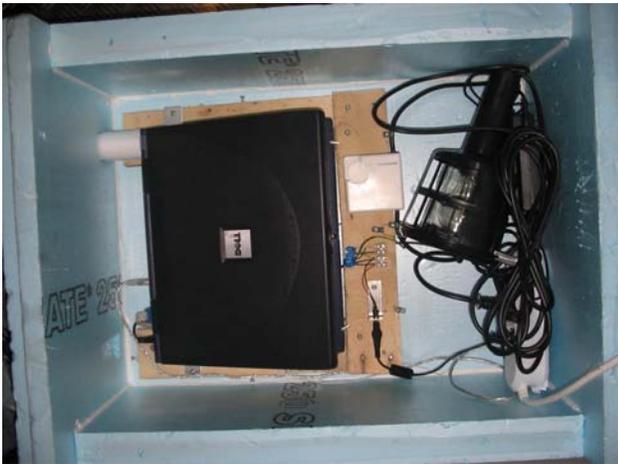
Figure 7: Data logging PC and power supply for HoloOptics.

Data acquisition was done with a direct connection to one of the pins on a serial port of a laptop computer, and a Labview script to read the status of the pin every three seconds and write it to a text file. This meant that the data files were larger than necessary, and perhaps it would have been better to only record the transitions between high and low. The laptop required a protective box to keep it warmer during the winter, so an insulated box with thermostat and a 60 W lamp for extra heating was constructed. This box also contained the power supply for the ice sensor and is shown in figure 7.
