SWEDEN'S BOLD ACTIVITIES IN MEASUREMENTS AND MAPPING OF ICING AND DE-ICING OF WIND TURBINES

Göran Per Rune Ronsten, WindREN, Stockholm, Sweden, goranronsten@windren.se

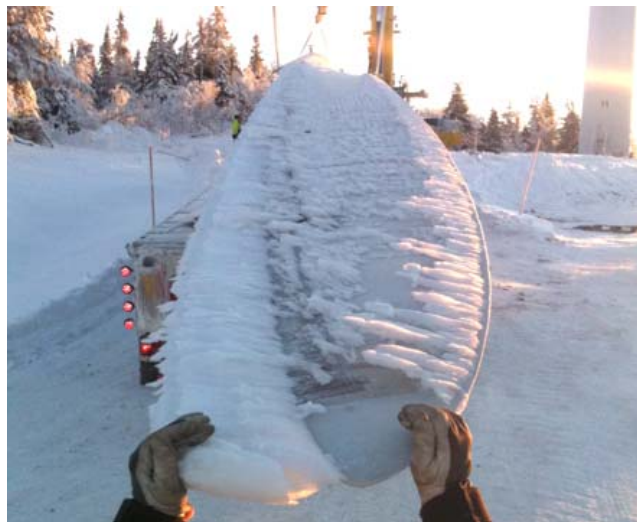
The ice collected on a wind turbine blade has been photographed as the blade was replaced.

Figure 3: Ice collected on a wind turbine blade.
