Damageability of Overhead Lines During Ice Storms in Ukraine

Abstract — In Ukraine the main problem of overhead transmission line (OHL) reliability during winter period is icing in combination with high winds. The greatest failures in Ukrainian overhead transmission network were in November 2000 during broad scale icing storm. Some statistical data of this icing event, its meteorological description and damageability of OHLs were proposed in comparison with older icing storms.

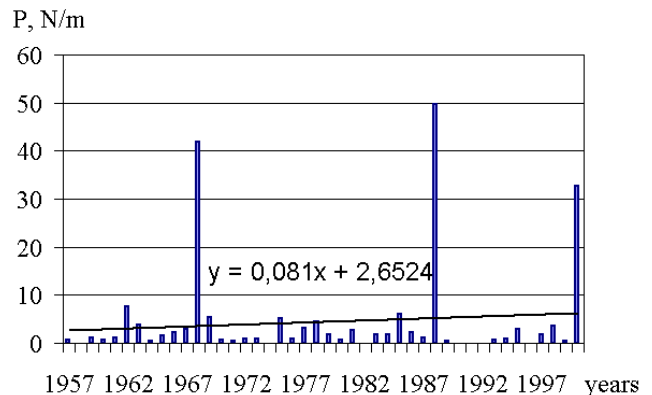
Fig. 2. Maximal annual mass of icing for South of Ukraine and its trend (weather station Odessa)

2). The most widespread peak was fixed in this region in November 2000.

The main reason of OHL damages in Southern and Western parts of Ukraine is imperfection of Ukrainian codes and rules [2] for overhead lines designing. Under climatic loadings processing peaks are not taken into account (see fig. 2) so the basic level of ice and wind with ice loads is lower than real ones.

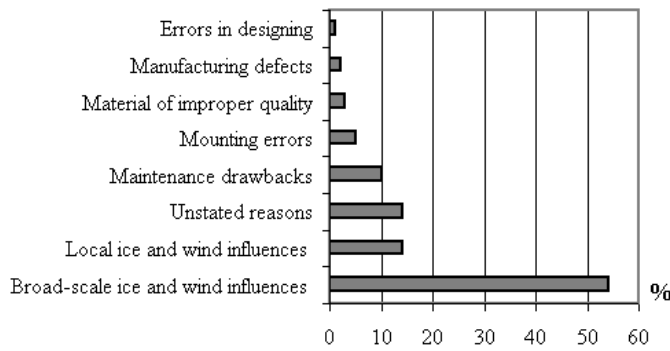
Fig. 3. Distribution of the quantity of failures depending on a cause

A lot of researches noted increasing of natural catastrophes in recent years, in particular windstorms. In Ukraine and Russia the frequency of windstorms increased in 1,6 – 2.5 times during the last few years by the data of different researches. These aspects influence on overhead lines reliability (see fig. 3), which gives a classification of failures depending on damage cause for OHL by voltage 35-750 kV, during 1971-2000 in Ukraine. Thus the main reasons of OTL failures are broad-scale ice and windstorms (more then 50% of damages), so the lessons of these events must be investigated.

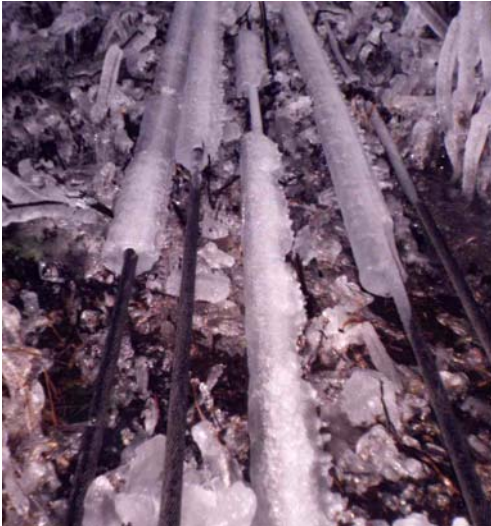
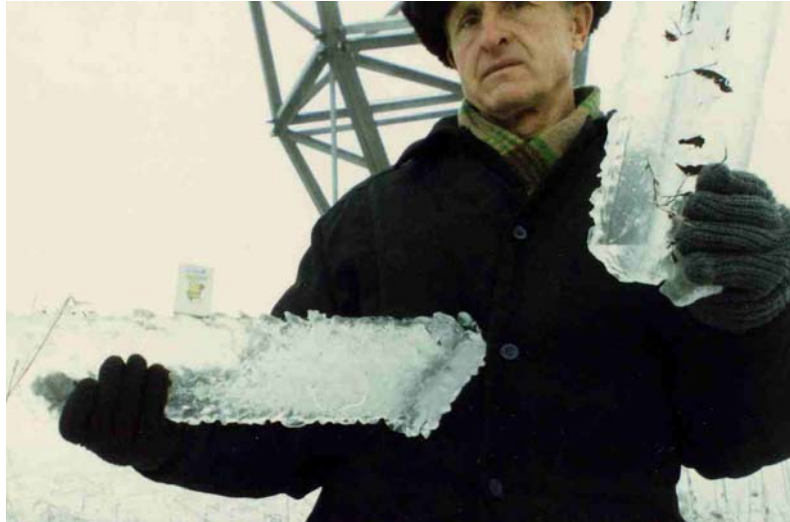
During the inspections the mass of icing from 3 kg per linear meter to 17 kg per linear meter (fig. 6) was observed.

The considerable distinctions of icing mass during inspections and recalculated with using weather stations data were determined. For example, icing mass 17 kg per meter was measured on OHL 750 kV "Dneprovskaya - Yuzhnoukrain-skaya" conductors, but recalculated mass with using data of weather stations equaled 6 kg per meter.

Fig. 6. Icing on OHL 750 kV conductors:
a) Isakcha - Yuzhnoukrainskaya

b) Dneprovskaya - Yuzhnoukrainskaya

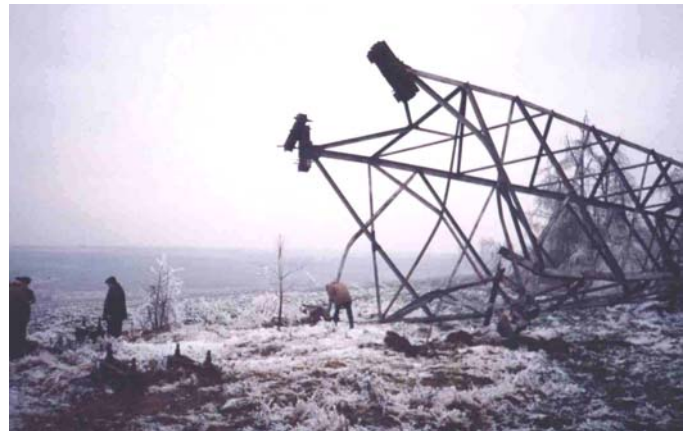
During icing events in November 2000 17 OHL by voltage 330 – 750 kV were damaged. There were damages of 507 towers, 127 conductor spans, 71 ground wire spans, 22 insulator strings and 3 foundations (fig. 7). There were 268 damages of reinforced concrete towers, 235 metal towers; over 80 percent of the damages were cascade. In dependence from failure parts there were detected for metal towers:

Fig. 7. Foundation failure of OHL 330 kV “LadTES – DsGRES”

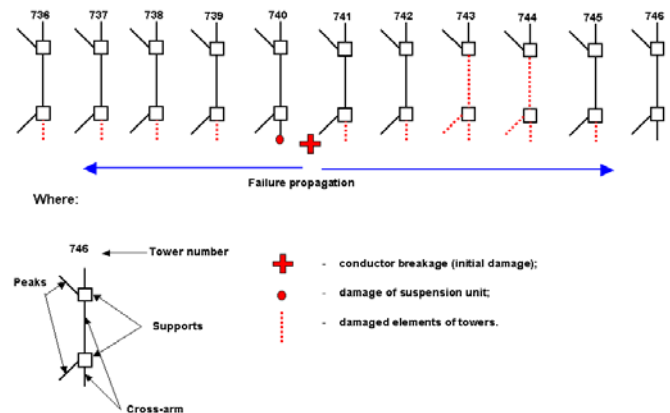
During long exploitation of OHLs the coordination principles of its mechanical strength were changed. For example on fig. 9 the failure propagation on OHL 750 kV "Yuzhnoukrainskaya – Dneprovskaya" is shown. Cable breakage was in span 740 – 741. Tower 740 was without damages because of suspension string breakage. The cross-arms on towers 736 – 739

and 741 – 745 were damaged. This example illustrates that in some cases using prevention methods such as reduction of insulator carrying capacity may prevent the tower damage.

Fig. 9. Damage of OHL 750 kV "Yuzhnoukrainskaya – Dneprovskaya"
