# Insulation Properties of Long Rod and Line Post Insulators for 33 kV Transmission Line in Wet-Snow Storm on January 2004

Noriyoshi Sugawara and Kazuhiro Hosono\*

**Abstract**—Snow-storm from 13th to 16th January 2004 in Okhotsk region in Hokkaido island of Japan damaged all traffic and stopped electricity. Long rod and line post insulators for the 33 kV transmission line were accumulated with wet-snow including sea-salt. The spaces between sheds were filled up with this wet-snow and then the insulator was a cylinder with a shed diameter. Therefore, the leakage distance was the same as flashover distance and the insulation properties decreased greatly. Flashover events might be caused by supplying salt-water film on the surface of wet-snow accreted on insulator. According to the experiments with simulated wet-snow between shads using material which absorbs water, dc surface resistance of long rod insulator in tension situation was approximately 10 times lower than that in suspension situation using salt water of a conductivity of 20 mS/cm which was an electrical conductivity of wet-snow collected in the area along the Sea of Japan where the outage of distribution lines occurred.

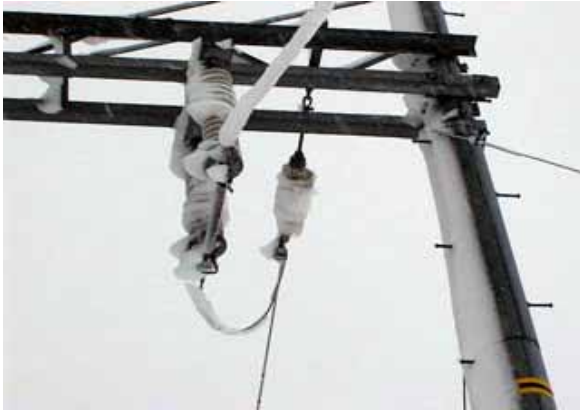
Fig.6 Transmission pole and insulators covered with snow after snow storm

Panzer transmission pole structure, long rod insulator and station post insulators covered with wet-snow for 33 kV

transmission line which faults happened, are shown in Fig.6. Wet-snow accreted on surfaces of these structures from the direction of seaside. For long rod insulator, wet-snow filled spaces between sheds up as shown in Fig.7 as compare with an ordinary long rod insulator as shown in Fig.8. Picture of Fig.7 was taken after flashover events, therefore accreted snow on both end fitting metal of the long rod insulator was melted by arc, and then the metal appeared. The relationship between coast of Okhotsk Sea and 33 kV transmission line was shown in Fig.9. This transmission line has been installed near windbreak forest along the coast. The shortest distance between the transmission line and the coast is about 500 m as shown in Fig.10.

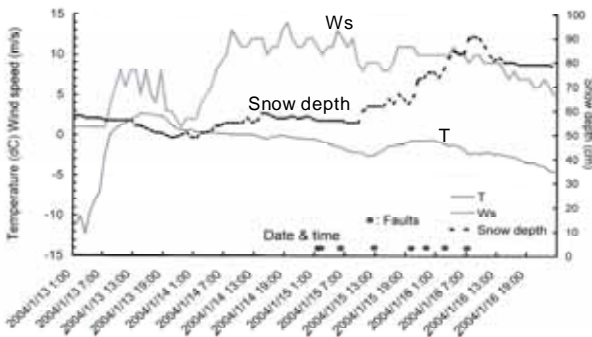
Fig.11 Weather data at faults

Faults as a result of wet-snow accretion included sea-salt and weather data are shown in Fig.11. Several outage faults occurred from 1:00 of 15th to the early morning of 16th at temperature from  $-0.5^{\circ}\text{C}$  to  $-2.5^{\circ}\text{C}$  and a wind velocity of about 10 m/s and under the conditions of increasing of snow depth in the direction of seaside. After these faults, transmission line could transmit electricity simultaneously. This means that wet-snow accretion on an insulator decreases the insulation and then flashover appears, consequently accreted snow on insulator is melted by arc heat and then the insulation recovers. The temperatures in the faults were below zero degree, because of freezing point of salt water being lower than zero degree. The insulation of wet-snow covered insulator decreased with decreasing of temperature as a result of increasing of conductivity of water film on snow and ice because of the excretion of salt nuclei from ice crystal when salt water freezes [7]. Moreover, it is clear that the increase of snow depth under wet-snow-storm supplied water included sea-salt with snowflakes on insulators continuously, and then

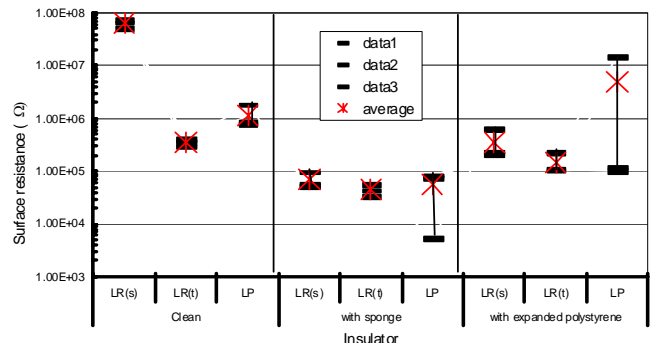
Fig.17 Surface resistance due to ice and snow accretion situations depending on install conditions

Results of 3 times experiment and their average for  $R_s$  under three kind conditions are shown in Fig.17.  $R_s$  under the conditions of wet-snow (mock-snow) were lower than those under ordinary and ice (mock-ice) conditions. This reason is that the conductivity and absorption of material inserted between sheds decreases the insulation. For LR,  $R_s$  of LR-s was higher than that of LR-t because of the presence of water line along the lowest position of sheds between end fittings of LR-t.

Surface resistance properties for wet-snow filled long rod and line post insulators decreased with increasing the conductivity of spraying water, and depending on install situations for long rod insulator. Surface resistance for long rod in tension situation was lowest than those for long rod in suspension situation and line post insulator. This lowest value may occur flashover of long rod in energizing transmission line in wet-snow-storm included sea salt.
