# An Investigation of Sea Spray Icing and Deicing on Membrane Structures

**Abstract**— Reduced visibility due to sea-spray ice accretion is a major problem for the operation of lighthouses in northern harbors. To address this problem we designed membrane structures that wrap a small lighthouse. The wet growth of spray ice was investigated through cold laboratory experiments. Small water particles with a diameter of approximately 0.1 mm were flowed to the test fabrics, and the icing occurred on the windward side of the fabrics. The experiments were performed using several materials. The ice-accreted fabrics were vibrated and we observed the state of exfoliation of ice and the structural features of sea spray icing. The field test was carried out at the west coast of Hokkaido, Japan. Two dummy lighthouses were set up on a breakwater. Several types of membrane were tested for wrapping the dummy lighthouses during the winter season. A spacing device was installed on the dummy lighthouse and the space of the membrane so that the membrane fluttered in the wind. Hydrophilic coating material and water-repellent coating material were noticeably different in both the icing growth process an

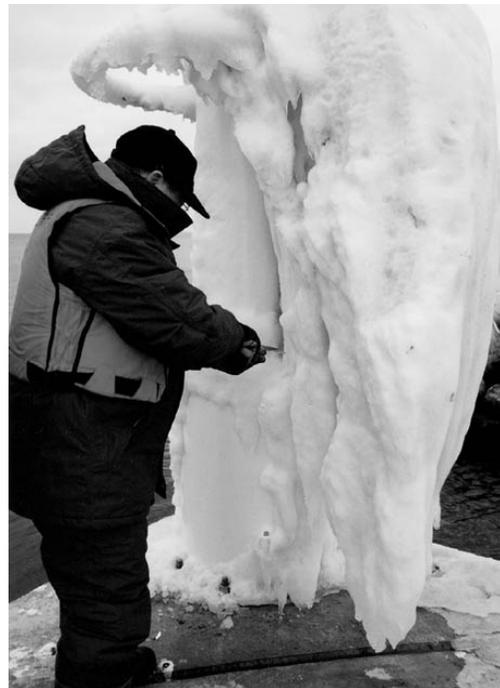
Fig. 1. Sea spray icing on a small lighthouse.

THE northern part of the Sea of Japan is famous for being a marine disaster zone because of spray icing. Figure 1 is a photograph of the sea spray ice accreted on a small lighthouse in Atsuta harbor, located on the west coast of Hokkaido, Japan. Reduced visibility due to sea spray ice accretion is a major problem in the operation of lighthouses in northern harbors.

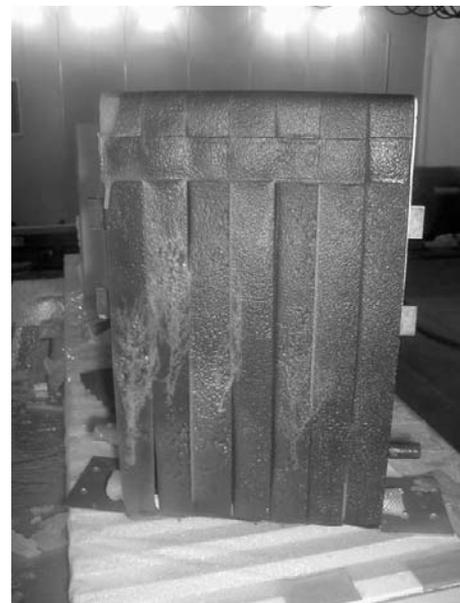
Fig. 4. Spray icing on fiber reinforced plastic belt.

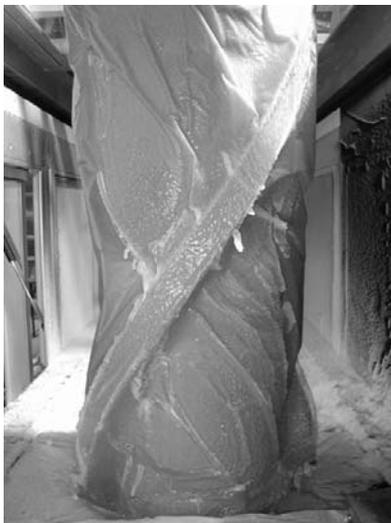
Fig. 7. Spray icing on waterproof nylon cloth with spiral-shaped spacer.

A spacing device was installed between the dummy lighthouse and the fabric, so that the membrane fluttered in the wind. The spacer was made of the spongy material. Figure 7 shows the membrane structure made of the waterproof nylon cloth and a spiral-shaped spacer.

In the nylon cloth model, exfoliation occurred due to the vibration generated by a strong wind. This exfoliation did not occur with other cloth models. This might imply that deicing was effective because the nylon cloth was flexible and icing was thin and uniform.

A difference was noted in the vibrations generated due to the variations in the type of spacer used and this led to differences in the deicing. The spiral-shape spacer propagated the vibration primarily to the larger area and stimulated deicing.

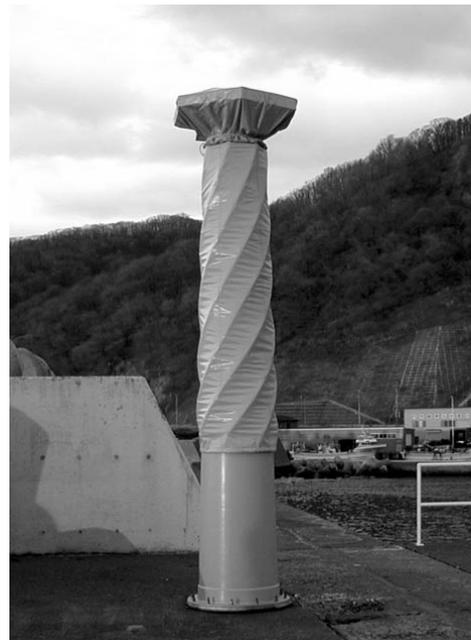
Figure 8 FRP lighthouse wrapped by membrane structure.

The field test was carried out at Hamamasu harbor, located on the west coast of Hokkaido. Two dummy lighthouses were set up on a breakwater extending from the north to the south. Several types of membrane models were tested for wrapping the dummy lighthouses during the winter season. A spacing device was installed between the dummy lighthouse and the membrane (Figure 8). A northwesterly wind generated a icing spray on the sea-facing side of the harbor, and the spray drifted intermittently toward the lighthouse. Ice accretion on the wrapped lighthouse was recorded by the monitoring system.

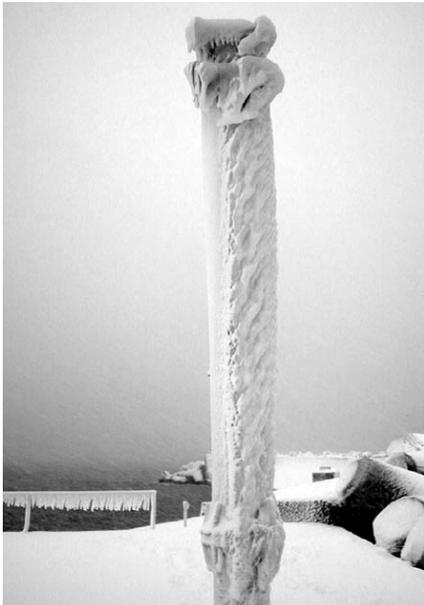
Fig. 9. Sea spray icing on steel dummy lighthouse.

Figure 9 shows the ice accretion on the dummy lighthouse without the membrane. The icing grew on the windward side of the lighthouse. A horizontal cross section of the ice accretion shows the presence of growth rings. Presence of brine was detected in it and the salinity of the samples was 7 ‰. Although the steel pile dummy lighthouse although was coated with a water-repellent coating of fluorine, ice accretion occurred most frequently on it. On the other hand, heavy icing on the membrane was rare. Figure 10 shows the ice accretion on the same dummy lighthouse where the membrane was wrapped around the bottom half. This figure appears to be clear that the membrane structure controls the growth of icing. In the case where the membrane was coated with thick icing, the cloth could not undergo fluttering or distortion and deicing was difficult.

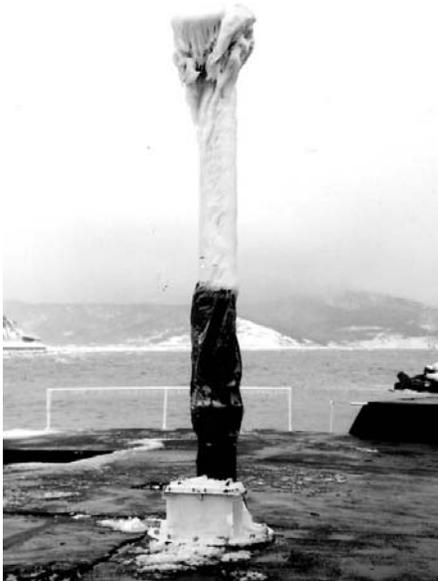
Fig. 10. Anti-icing effect of membrane structure.
