TECHNOLOGICAL DEVELOPMENTS FOR THE STUDY OF GUY CABLE DAMAGE INDUCED BY ATMOSPHERIC ICING ON HIGH VOLTAGE TRANSMISSION LINES

D. Gagnon¹, G. Roberge¹, X. Zhang^{*2}, G. McClure²

Abstract: This paper summarizes the experience of Hydro Québec with the development of wind-induced-vibration damping solutions for support cables of guyed transmission towers in extreme Nordic environment.

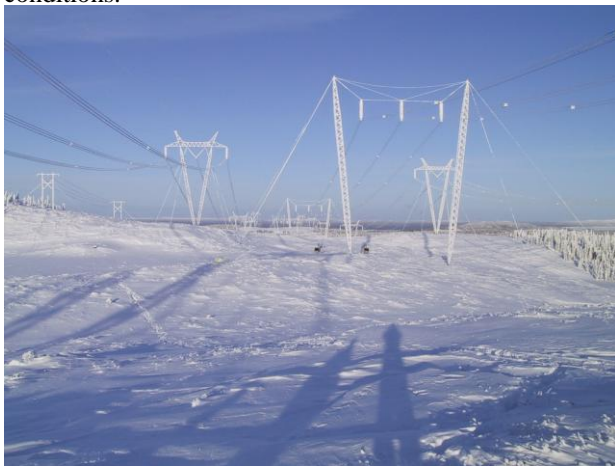
Figure 1. Hard rime accretion on James Bay transmission network

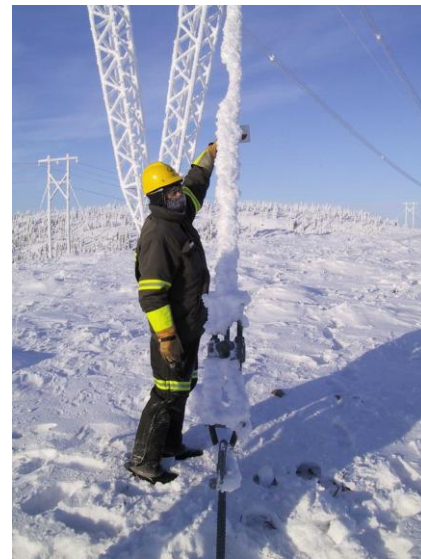
Figure 2. Detail of rime accretion on support cable

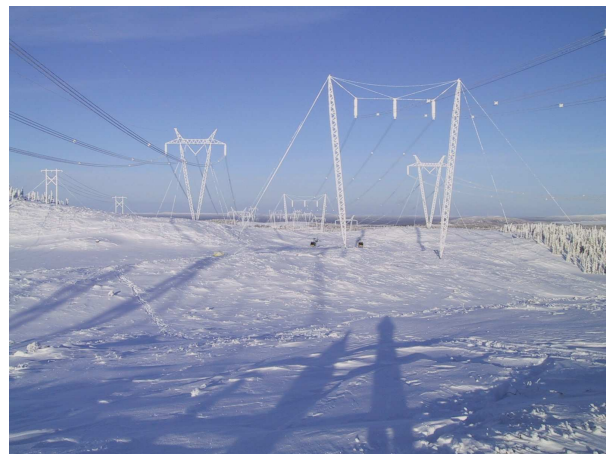
Figure 1: Rime accretion on James Bay network structures

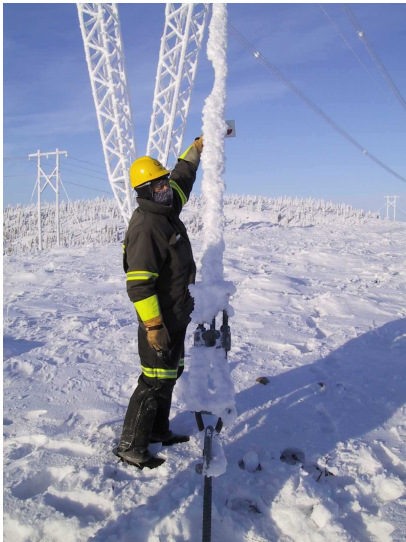
Figure 2: Large hard rime accretion on guy cable

Rime and/or glaze ice accretion on overhead power line conductors and supports are most often caused by freezing rain [2]. However, in this study, the hard rime deposits are attributed to freezing fog. For a given site or line corridor section, a good indicator of the likelihood of accretion is provided by the wind rose which is a handy tool as it indicates the direction, speed and frequency of the winds. In the James Bay region of Québec, the terrain is rather flat and open, free of obstacles for long stretches. Also, as the terrain presents a very gentle slope on great distances, the main horizontal wind flow is accompanied by a light lifting of air along certain wind directions. On cloudy days, supersaturation of air is easily reached on higher locations where terrain elevation reaches cloud bases. In such areas, line conductors and their support structures happen to be higher than the cloud base; in fact, they are surrounded by fog which is made up of supercooled micro droplets. As long as the wind keeps its direction and a minimum speed, the supersaturation tendency (cooling rising air) causes rime formation on objects. With time, these accumulations may become important. Also, episodes of very cold temperatures that may follow freezing fog events can contribute to harden these rime accretions and make them adhere more strongly to tower members and support cables. Such hard rime deposits are difficult to shed in ambient conditions. As a result, towers can stay covered and exposed to wind for extended periods of time of several weeks. Figure 2 shows an example of large hard rime accretion on a support cable, typical of the cases reported as critical.

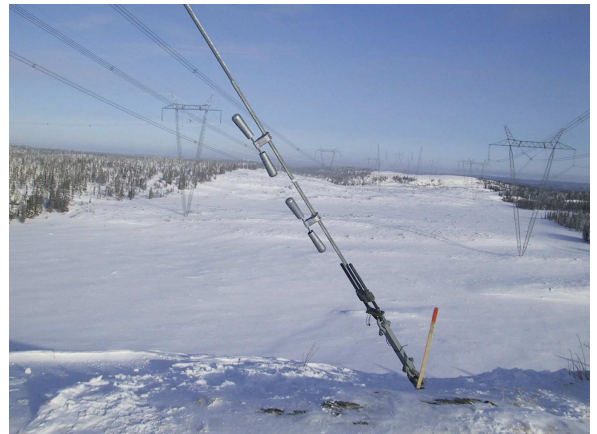
Figure 3: Dampers installed on guy support cables (James Bay 735 kV network)

Hydro Québec has been using vibration dampers to prevent premature failure of guy wire anchor rods on its high voltage transmission network for over 15 years [1]. As shown on Fig. 3, these are Stockbridge dampers, which have been used with great efficiency to mitigate vibration in line conductors. However, in recent years, maintenance surveys have indicated a number of damper failures (see Fig. 4) at rime-prone tower sites with rock anchors. The most critical structures were the chainette towers – also called cross-rope suspension towers, on lines located in the James Bay and Lower North Shore areas. This type of structure has four steel support cables to maintain the two lattice masts and the cross-rope suspension in their upright position. A good example of a critical site located in James Bay is shown in Fig. 1 where the supports are fully covered with white rime while the line conductors are bare. A chainette tower is seen in the foreground while guyed-V and H-frame supports appear in the background as several transmission lines share this same corridor.

chainette towers. Nonetheless, these guyed towers are relatively flexible – especially the chainette type – when compared to the more traditional four-legged latticed self-supporting towers. Wind-induced vibrations have been a concern for chainette towers since their inception and in 1992, Hydro Québec (IREQ Expertise Mécanique, Métallurgie et Civil) started to conduct a major study to develop passive damping solutions adapted to the support cables of the chainette towers. An example is shown in Fig. 3 where two tuned-mass Stockbridge type dampers are installed on a guy cable. To date, more than 6500 dampers have been installed on the guy cables of chainette towers in the high risk areas.

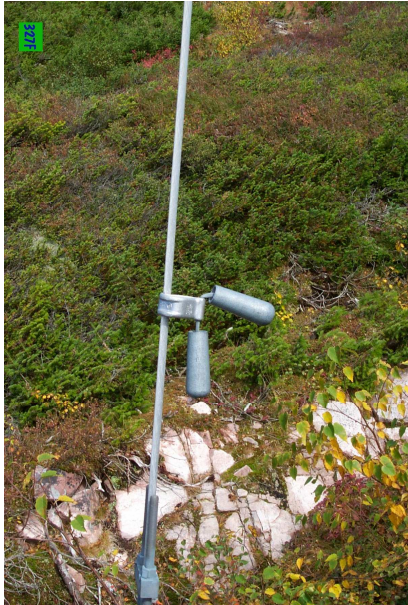
Figure 4: Typical damper failure of initial damping solution for guy support cables

F is therefore independent of the vibrational properties and boundary conditions of the oscillating cable. Large rime accretions on cables increase their equivalent diameter and the increased area exposed to wind generates considerable vibration power input in the cable as this power input is a function of D^4 . The initial selection of the Stockbridge dampers used on the guy cables was essentially based on the extrapolation of the tuned-mass damping model used to mitigate Aeolian vibrations in overhead conductors, with appropriate equivalent conductor diameter. This solution did not prove fully effective as damaged dampers (see Fig. 4) were observed at several sites on rock. It remains to be established whether or not the damaged dampers still served

The monitoring study enabled identification of the recurrence of vibration events and the frequency and magnitude of the oscillations of the head of the anchor bars. Laboratory testing of damaged dampers has enabled to gain a better understanding of the phenomenon and helped in designing a tailored solution to prevent further damage to the anchoring system. These tests have shown that the failure mode observed in the field was not caused by Aeolian vibrations but rather by a high amplitude low frequency mode more related to galloping. Subsequent over sizing of the dampers was implemented and proved to be effective for the long term protection of the guy cable anchoring system. At present, this is the mitigation solution employed at rock sites, while sites on soil have not shown any signs of such vibration problems. However, a few incidents of damper failures have been observed despite the implementation of the improved solution.
