ANALYSIS OF HUNAN POWER GRID ICE DISASTER IN 2008 AND RELATED SERIES ANTI-ICING TECHNOLOGY RESEARCH

Abstract: At the beginning of 2008, the extreme climate phenomena caused by global warming, ice disaster process, and influence on Hunan power grid were systematically presented and analyzed. Transmission and transformer equipment losses were statistical analyzed.

Analysis of Hunan Power Grid Ice Disaster in 2008 and Related Series Anti-icing Technology Research

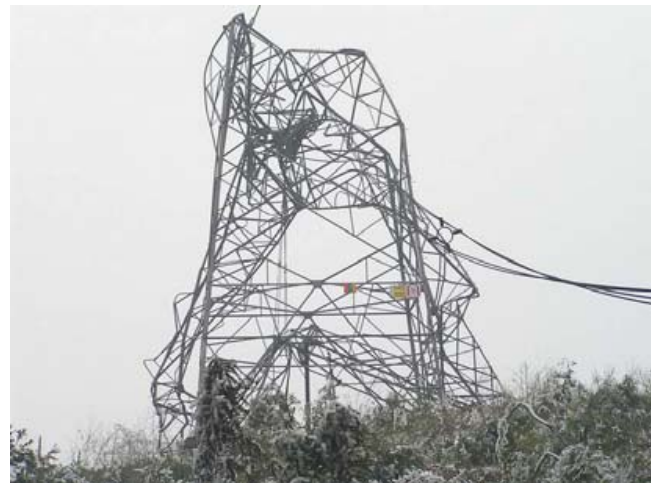
There were 182 collapsed towers and 68 transformative towers in 500kV power lines. 159 pieces of conductors and 322 pieces of ground wire were either broken or damaged. Insulators dropped at 284 spots.

Fig.1: #390 collapsed tower of 500 kV Wumin line

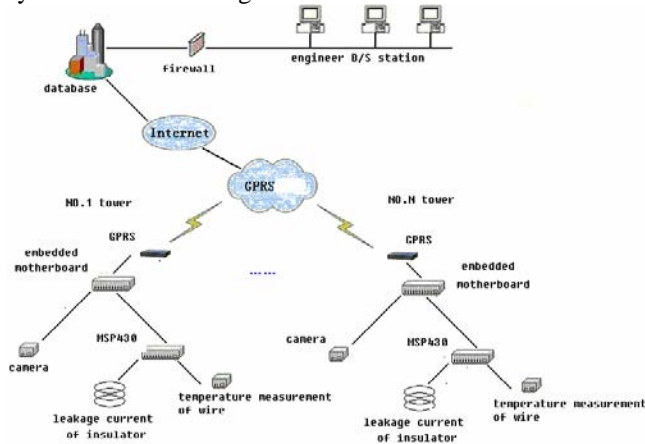
An embedded system seated on towers is the data platform of ice monitoring system. The system connects with Internet through GPRS (CDMA) net. The data platform focus the data on special server installed on ice

monitoring center of Hunan Power Grid. The structure of system is shown in Figure 2.

Fig.2 structure of system

The system is made up of five parts:

1) Data acquisition device of field MCU. It can implement data acquisition function and sample 32 discrete data points in one cycle. The type of system's CPU is MPS430. The acquired data includes leakage current, CO content, meteorological parameters and so on.

2) Embedded system. Arm7 is the kernel of embedded system. The main function of system includes collecting and sending ice images, transmitting data collected by MCU and server monitoring order.

3) Server system. Server system includes server program and alarm scheduling program. It is used mainly for managing message of embedded system and transmitting alarm scheduling program and control message of client. Alarm scheduling program's function mainly includes collecting timing data, automatic diagnosis of ice-covering thickness and saving the data to database.

4) Client software. The function of client software mainly includes control of camera and rotational station, real-time data acquisition. It is operated by connecting with embedded system through server-side software.

5) Web data publishing system. The function of web data publishing system includes displaying real-time data, searching historical data, searching historical trend and displaying image. It is convenient for working staff to browse monitoring data with browser. Data can be picked up from database by the web data publishing system [6].

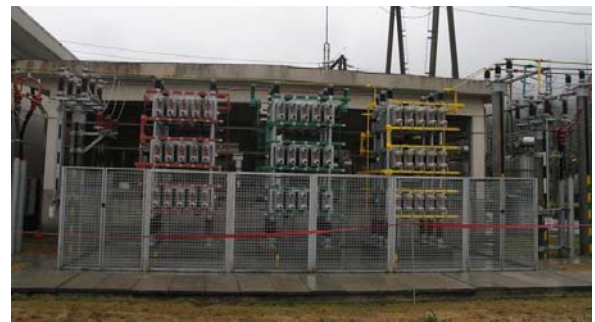
Regulative Capacitor Series—Wound Compensate AC De—Icer is mainly made of capacitance (Figure 3), it is applicable to 220kv lines whose length range is 0~40 km. The structure of devices is three-phase type, per phase is made up of 3 capacitorbanks and per capacitorbank is composed of 10 capacitors by parallel connection. By the

way of series parallel of 3 capacitorbanks and choosing the parallel number of per capacitorbank, capacitive reactance can be regulated smartly. Technology parameters of devices are as follows:

Normal rated current: 1600A;

Normal rated voltage: 15kV

Normal rated capacity: 26.1Mvar

Normal line length of melting ice: 0~40 km 220kv lines and below

Fig.3 Regulative Capacitor Series—Wound Compensate AC De—Icer

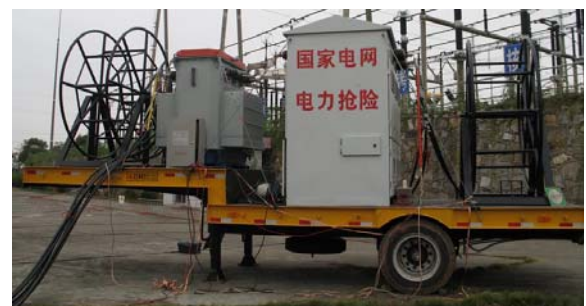
Diode is used as the rectifier element of Mobile DC De-Icer which is connected by 6-Pulse Wave bridge rectifier. In the case of without voltage adjusting, the melting ice devices can meet the needs of 50~150 km power lines melting ice by the way of Six-pulse converter bridge rectifier and reasonable adjustment of transmission line connection mode [8]. The appearance of devices is shown in Figure 4. The main technology parameters of devices are as follows:

Normal rated power: 25MW

Normal rated output DC: 2000A

Normal rated output DC voltage: 12 500 V

Normal line length of melting ice: 50~150 km

Fig.4 Mobile DC De-Icer

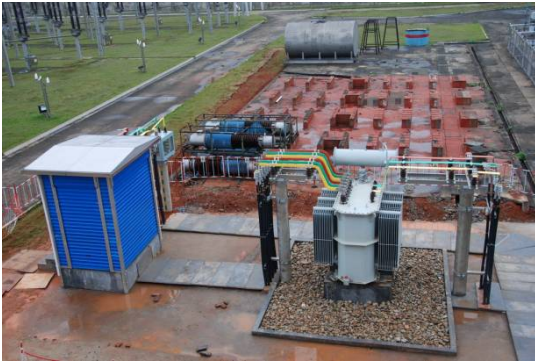
Fixed DC De—Ice is made up of rectifier transformer and 12-pulse wave controllable rectifier (Figure 5). The output dc voltage of devices can be started to regulate from 0V. it is applicable to lines whose length range is 0~40 km. Technology parameters of devices is as follows:

rated power: 4.2 MW

rated output DC: 1 400A

rated output DC voltage: 3 000 V

line length of melting ice: 0~40 km

Fig.5 Fixed DC De—Icing Device
