INFLUENCE OF ICE THICKNESS ON DC FLASHOVER VOLTAGE OF ICE COVERED INSULATOR STRING

Abstract: Icing flashover voltage is found to be influenced by ice thickness of insulators. In this paper, the icing flashover voltage of icecovered insulators with various ice thickness is studied under dc test condition. The ice thickness is represented by a icing measuring system with a rolling test stick contain. Through tests, features of different ice covered statues are observed with voltage energizing, and the relation between the ice thickness and icing flashover voltage are also studied. All test results show that the icing flashover voltage go decline if the ice thickness increase; when the ice thickness reach certain value, the flashover voltage becomes saturation.

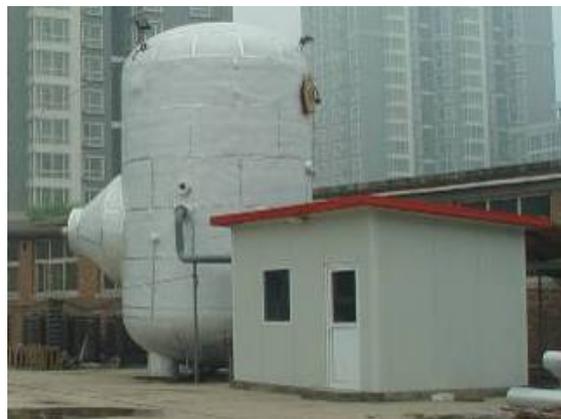
The experimental investigations were carried out in the artificial climate room in the China Electric Power Research Institute. The artificial climate room has a diameter of 4 m and a height of 7 m, which is shown in Figure 1. It mainly consists of refrigeration system, vacuum-pumping system, and spraying system. The air temperature in the artificial climate room can be adjusted from -19°C to 0°C by the refrigeration system which meets the requirements of ice accretion test under different temperature. The air pressure in the room can be set as low as 50 kPa, which can simulate the atmospheric conditions at high altitude area.

Figure 1: Artificial climate test room.

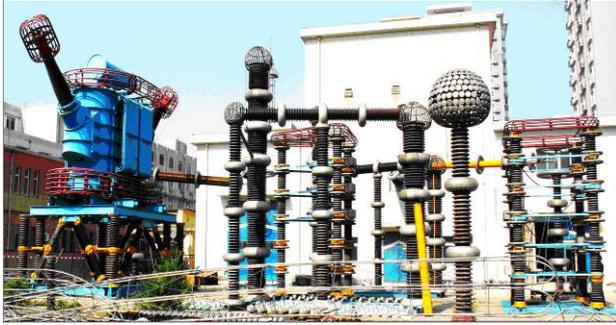
The power supply was a ± 600 kV thyristor-controlled dc source which is shown in Figure 2. It mainly consists of control unit, column type voltage regulator, silicon-controlled voltage regulator, step-up transformer, rectifying circuit and measuring systems. The voltage and leakage current signals transferred through cable will be collected and analysed by computer which is available for monitoring and recording the real-time data.

Figure 2: ±600 kV DC power supply.

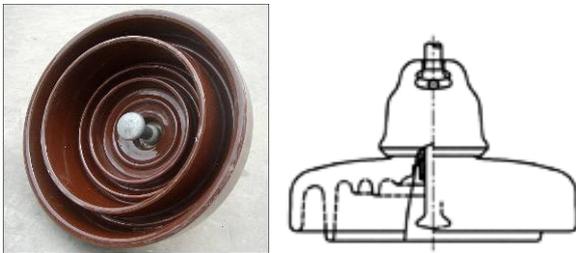
The type of specimen is XZP-210 porcelain insulator. The geometric parameters of the test insulators are shown in Table 1 and the profile of the XZP-210 is shown in Figure 3.

Figure 3: Profile of the XZP-210 insulator.

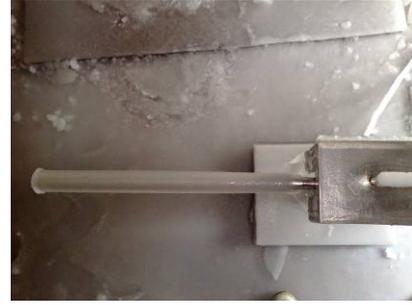
The thickness measuring device is a rotating cylinder, which is 600mm long and has a diameter of 30mm. The device can rotate in a constant rate (about 1r/min). The ice thickness on the cylinder can be regarded as the thickness on the test insulator. To eliminate the influence of different test position, the device is fixed near the test insulator. The rotating cylinder and thickness measurement of ice are shown respectively in Figure 4 and Figure 5.

Figure 4: The rotating cylinder.

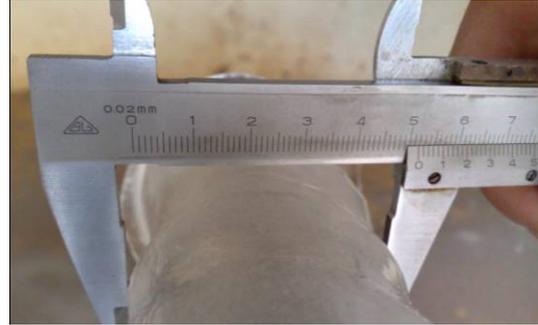
Figure 5: Thickness measurement of ice.

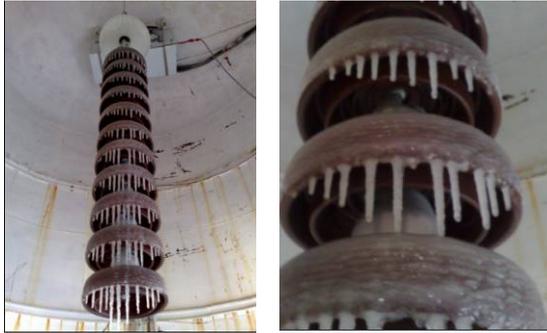
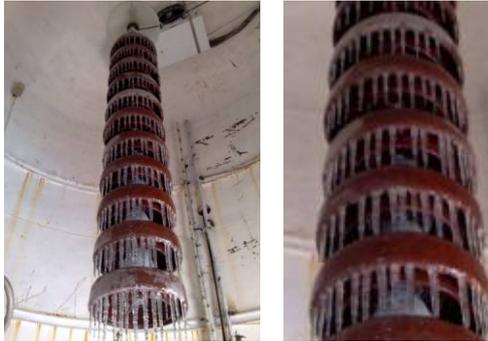
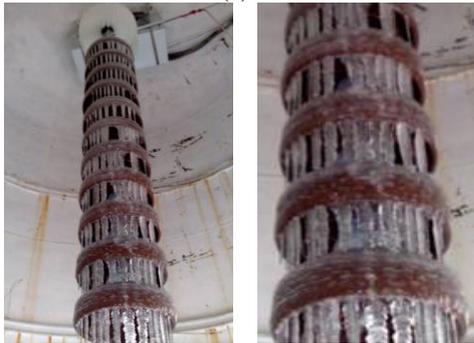
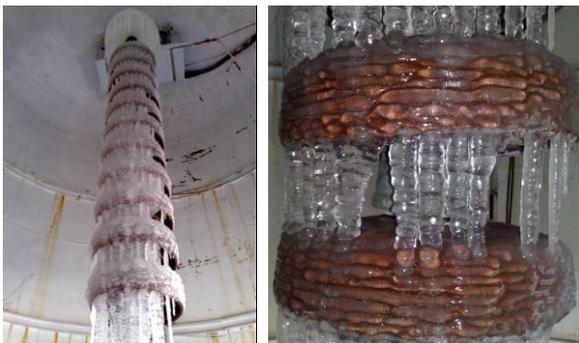
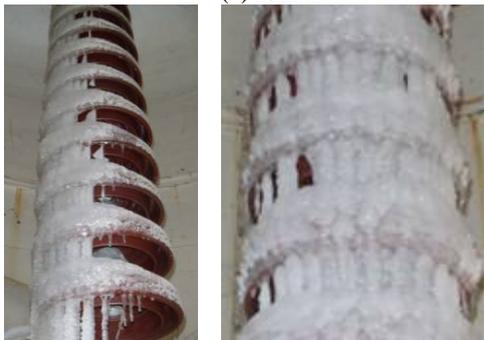
A string consisted of 11 pieces of XZP-210 insulators and the ice thickness is 5mm, 10mm, 15mm, 25mm, 28mm respectively. The Insulator Strings with various ice thicknesses are shown in Figure 6.

It can be found in Figure 6 that with the ice thickness of 5mm and 10mm, the insulator sheds were bridged incompletely by icicles. Especially with the ice thickness of 5mm, the air gap was still very large. With the ice thickness of 15mm, the insulator sheds had been bridged by icicles already. The insulator sheds are bridged completely by icicles along with no air gap between sheds with the ice thickness of 25mm and 28mm.

Figure 6: Insulator strings with various ice thicknesses

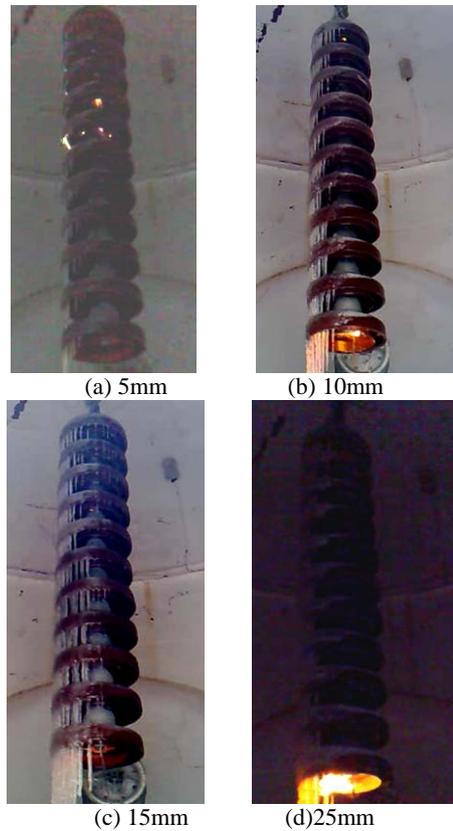
Due to the different voltage distributions along the surface of insulator and ice coat, the ice thickness have an important effect on voltage distribution, which can be figured out according to different flashover process. As shown in Figure 7(a) arcs appear between the sheds in the middle of most insulator strings with the ice thickness of 5mm, which indicates that the insulator string form dominates the voltage distribution on insulator string surface and lead to well voltage distribution along with random position of arc. With the ice thickness of 10mm, arcs appear on the end of strings (high voltage end) as well as slight arcs on the top. With the ice thickness of 15mm and 25mm, arcs appear on the high voltage end of strings. Arcs will be more dramatic on insulator string with thicker ice coat.

Figure 7: The Arcing Position of the Insulator String With Different Ice Thickness

The condition of ice coated on the insulators and the distribution of voltage along the strings were quite different under various ice thickness. And the arc positions changed if the ice thickness was different.

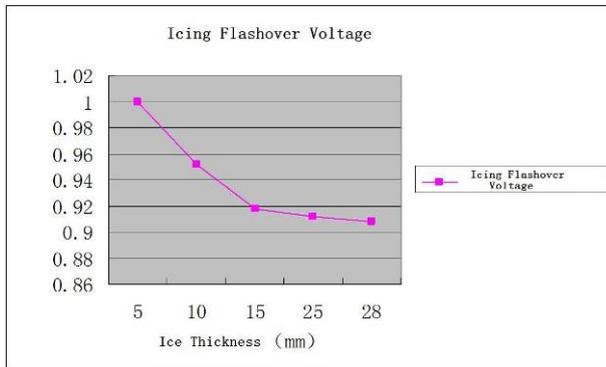
In order to study the relationship between ice thickness and flashover voltage, ESDD and NSDD which are the most relevant parameters of insulator precontamination are kept constant (0.05 mg/cm^2 and 0.3 mg/cm^2 respectively). The insulator sting still consist of 11 pieces XZP-210 porcelain insulators. To avoid the influence of results dispersion, several experiments have been done and the average value was taken. Meanwhile, in order to compare results under different ice thickness, flashover voltages under various ice thickness are calculated, taking flashover voltage under 5mm ice thickness as standard value. All test results are shown in Figure 8. The icing flashover voltage was represented by the per-unit value, of

which the standard value came from the icing flashover voltage under the test condition with 5mm ice thickness.

Figure 8: Relationship between icing flashover voltage and ice thickness.

The results available in Figure 9 show that an increase in ice thickness causes a decrease in flashover voltage of insulators.

It seems that the flashover voltage levels off when the ice thickness is up to 15mm along with completeness of bridging between insulator sheds. It can be concluded that 15mm ice thickness can be adopted as the ideal thickness of ice accretion test for evaluating the icing flashover voltage of insulators under heavy ice covered condition.

An increase in ice thickness causes a decrease in flashover voltage of insulators. It seems that the flashover voltage levels off when the ice thickness is up to 15mm. It can be concluded that 15mm ice thickness can be adopted as the ideal thickness of ice accretion test for evaluating the icing flashover voltage of insulators under heavy ice covered condition.
