PRE-FAILURE DIAGNOSIS OF SUBSTATION ELECTRICAL EQUIPMENT UNDER ICING CONDITION AND PREVENTIVE TECHNIQUES

Wang Tao, Ruan Ling, Deng Wanting, Zhu Changcheng, Wang Yongqin
Hubei Electric Power Testing & Research Institute
Wuhan 430077, China

Pre-failure Diagnosis of Substation Electrical Equipment under Icing Condition and Preventive Techniques

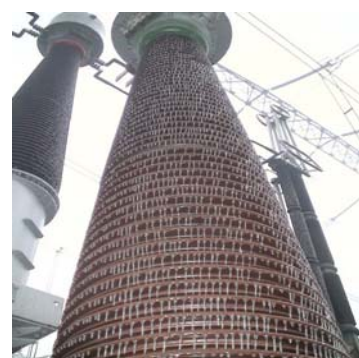
Figure 1: The surface icing state of 5012 Phase B, 500kV YuXian Substation.

Icing flashover is that the ice-coated insulators' shed cluster is bridged by icicle, resulted in lower flashover voltage of external insulation. Especially the uneven ice appearing on the surface of insulators, due to the uneven distribution of longitudinal potential. It may cause the flashover of equipment's external insulation easily. The icing flashover is shown in Fig.1 and Fig.2.

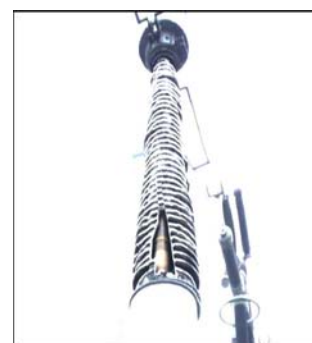
Figure 2: The surface accidental situation of 5013 Phase C, 500kV YuXian Substation.
