Analysis and Prevention Measures of Trapping of 1000kV ChangNan I Line

Li Junfeng¹, Shi Shengzhi¹, Dong Bingbing² and Jiang Xingliang²

Keywords-1000KV ChangNan I line ; insulator icing flashover reason analysis ; preventive measure ;

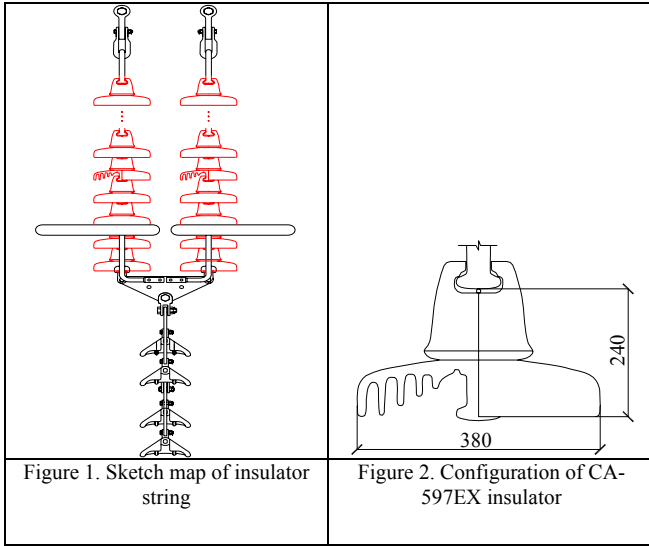
Figure 1. Sketch map of insulator string

The configurations of the 667th insulators are two strings hanged both sides of the phase which was showed in figure 1. The configuration of the insulator was showed in figure 2, and every string has 44 insulators. The length of the insulator string is 10.56m, and the length from the hanging point to the bottom of the drape joint plate is 11.815m. The middle phase string is V-shaped double-string, the length of the string is 10.56m. The length of the V-shape string from the hanging point to the bottom of the joint plate length is 12.355m.

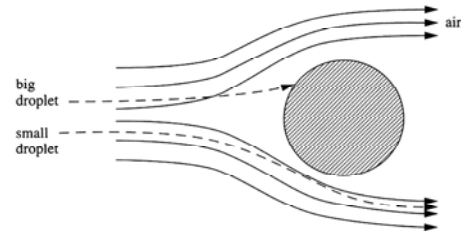
Figure 12. The direction of flow and the track of droplet around the cylinder

Where, A is the effective cross sectional area of object. The factor α_1 , α_2 and α_3 are less than 1. They represent a process of possible maximum reducing value dM/dt . The factor α_1 is the collision rate or the average collision rate of the particle. That is the ratio of density of the collision particle and the particle flux density of the air. However, this parameter changes with particle size because small particles with the air flow away more easily, so the parameters will be small. It can be shown as figure 10.

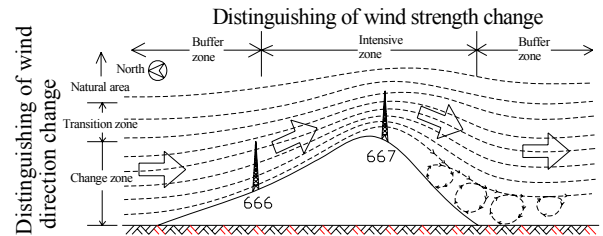
Figure 14. The sketch map of lifting of flow air when meet the steep hill

rapid uplift of the micro-topography terrain. The direction of cold air from the North gradually changed from the level of oblique when meet the upward elevation of 665 ~ 667 of the mountain, and the wind speed gradually increased. At the same time, the humid air lift valley to the mountain top and wind speed, humidity Peak, and then gradually slow down over 667, shown in Figure 12. Changes in meteorological parameters increased the formation of ice on insulator, leading to transmission line icing load increases. The patrol officers have a personal experience during they patrol from the foot of the mountain road to the place at tower 667th. With the increase of the altitude patrol officers climbing, the wind speed v increase gradually from small to big, the temperature increase gradually from high to low. On the peak, humidity w is relatively large. According to the equation (2), the larger of the wind speed the more ice. So, the icing is gradually serious with the rise of terrain of the 665th~667th tower.

To sum up, the weather in the surrounding factors, ecological factors, combined effects of topographic factors, this section of easy-to-north direction of the wind in the air formed under the uplift, strengthen, humidity increases, so the formation of small-scale lead to cover micro-meteorological area cause rapid formation of ice.
