ANALYSIS AND SIMULATED RESEARCH OF TOWER COLLAPSE BY ICE DISASTER OF HUNAN IN 2008

Lu Jiazheng, Xu Xunjian *, Liu Chun, Fang Zhen, Li Bo, Zhang Hongxian
Power Transmission and Distribution Equipment Anti-icing & Reducing-disaster Technology key
Laboratory of State Grid, Hunan Electric Power Test and Research Institute, Changsha, China, 410007

Abstract: The damage of the transmission lines in Hunan during the 2008 ice storm is surveyed and the main causes of the tower collapses and line failures are analyzed. It is found that the situation may be worsened by the nonhomogeneity of the ice accretion due to microtopography and micrometeorology conditions, span distance, and the imbalanced tension caused by vertical load. Meanwhile, simulation models of power transmission line and tower using finite element method have been proposed and developed. It is pointed out that great differences of span and angle of height are the main factors which cause unbalanced tension and make tower falling down. The computation results of 500 kV Fusha line I show the finite element method is very effective.

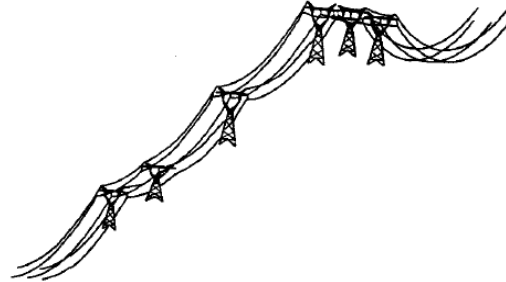
Figure 1: Transmission system's finite element model of Fusha line I

The model of finite element calculation is proposed and developed. It is pointed out that great differences of span and angle of height are the main factors which cause unbalanced tension and make tower falling down.

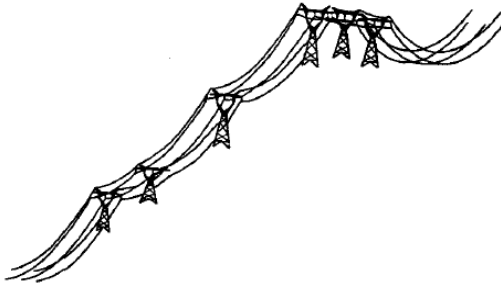
Figure.3 Transmission system's finite element model of Fusha line I

Designed ice accretion thickness of calculation segment in Fusha I line is 15mm,20mm is used to check. Model of tower can be created by beam element; cross section of beam element is "L". [6]Model of lines, ground wire and cable can be created by cable element based on catenary's equation.[5] The model of finite element is shown in Figure 3. Calculation units is mm and kg.

Unbalanced tension is the main reason for tower collapses. When towers is in lines whose span distance or angle of height differences is great, unbalanced tension acting on towers increases with d . When stress of tower caused by unbalanced tension achieves yield strength of
