Energy production losses due to iced blades and instruments at Nygårdsfjell, Sveg and Aapua

Matthew C. Homola¹, Göran Ronsten² and Per J. Nicklasson¹

¹Narvik University College

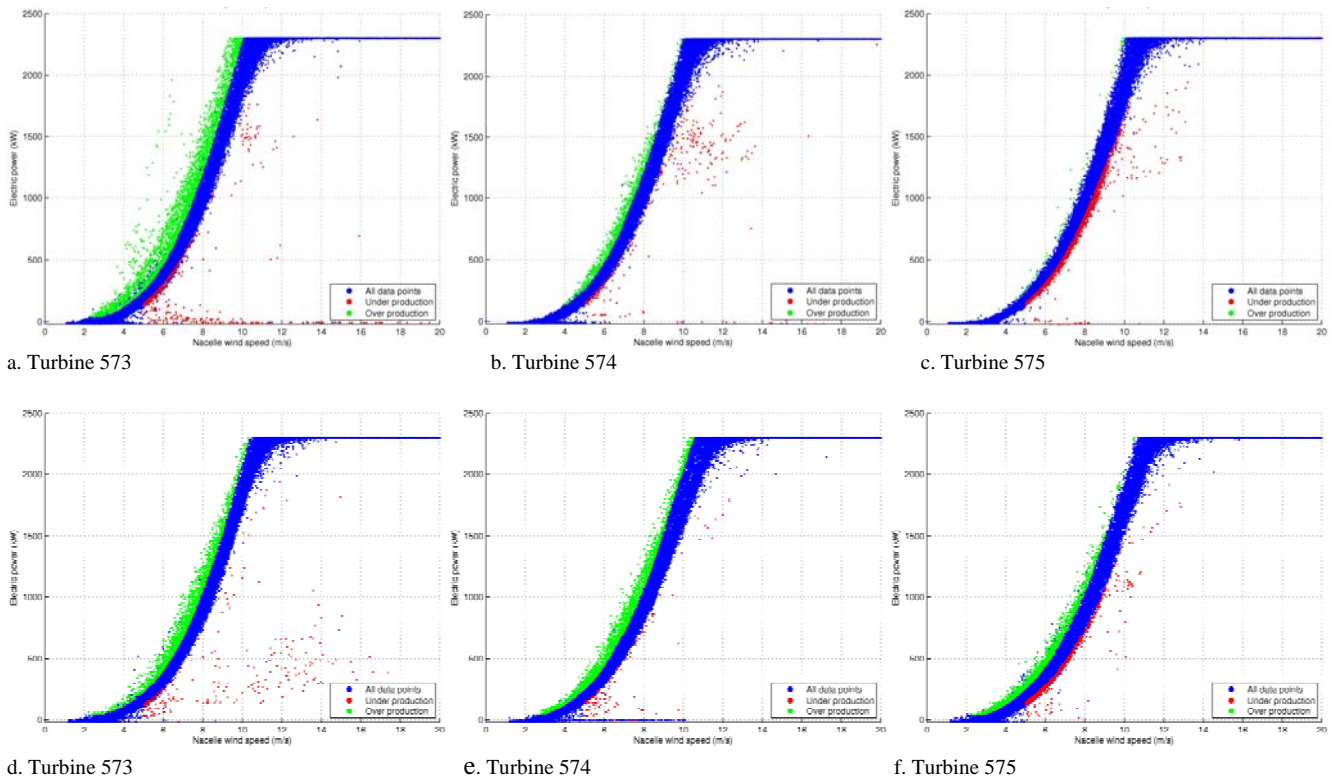
Figure 1: 10 minute production data from Nygårdstjell showing all data in blue, overproduction in green and underproduction in red. Subfigures a, b and c are from 2007-2008, while d, e and f are from 2008-2009.

Finally, plots of the power production data from the turbines, with all data points plotted in blue, and the areas of over and under production plotted in green and red respectively are shown in figure 1.

These figures also illustrate that there were problems with the wind measurements during both winters.

Some of the difference in the power data figures between the two winters is most likely due to the NRG Icefree 3 anemometers, which were present during the 2007-08 winter, being replaced with sonic anemometers. It appears that the combination including the sonic anemometer gives results that appear consistent between the turbines.

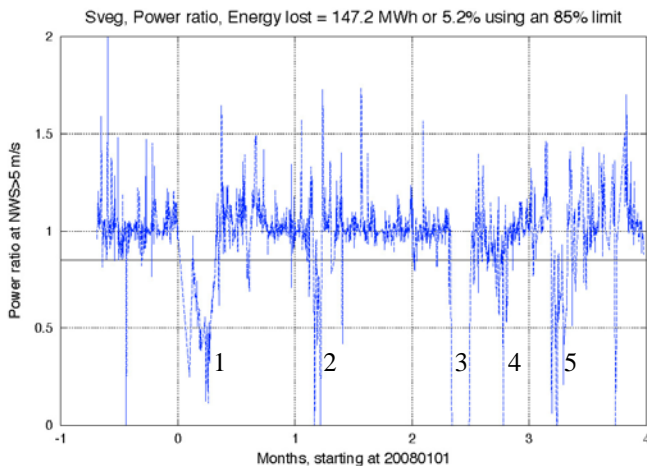
Figure 2: Five periods of icing. The energy production loss due to icing is estimated to be 5% during the period shown. The threshold shown is at 85%.

The analysis of power performance data shows that icing of the Sveg wind turbine caused an energy production loss in the order of 5%, or 150 MWh out of totally 2.8 GWh, between 2007-12-11 and 2008-04-30.

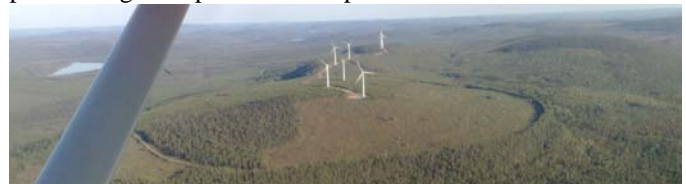
The Aapua wind farm consists of 7 V82-1.5 MW on Etu-Aapua, a hilltop in the Municipality of Övertorneå and was put into regular operation in Sep 2005.

Figure 3: Aapua wind farm on Etu-Aapua.

It is well known by the owners that icing has significantly influenced the power performance of the Aapua wind farm. The magnitude of this effect has, however, not been investigated previously.

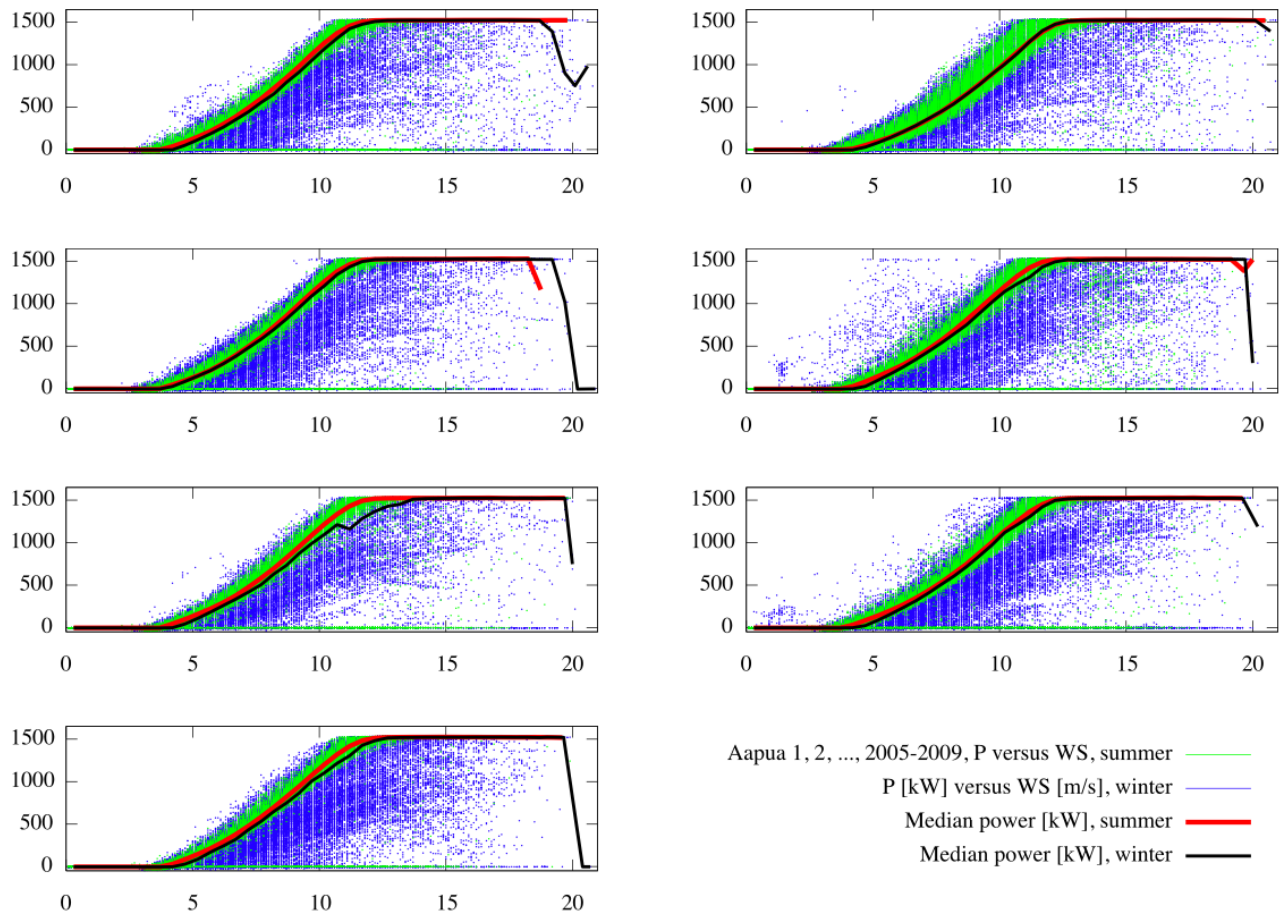
Figure 4: 10-min data plotted for three summers and four winters from October 1st 2005 to March 31st 2009. As data for the winters were plotted first, data for the summers (green dots) are placed on top of the winter data (blue dots). Aapua 1 is top left, Aapua 2 is top right etc.

The increased spread in power performance data during the winters is obvious and significant.
